Judgment of collapses and settlements from orthoimages: the method of pathological analysis in the Escuelas Pías church (Valencia)

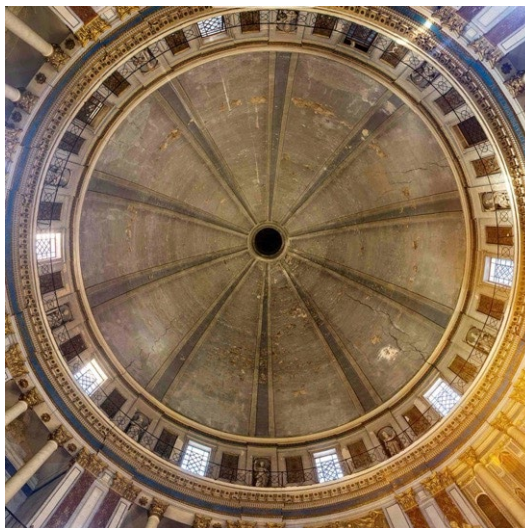
Fig. 1 - Interior view of the dome with the cracks.

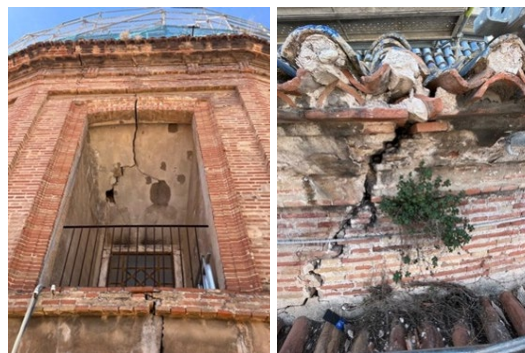
Fig. 2 - Cracks in the lintel and flare of the drum window (left) and in the second ring of the drum where it meets the roof (right).

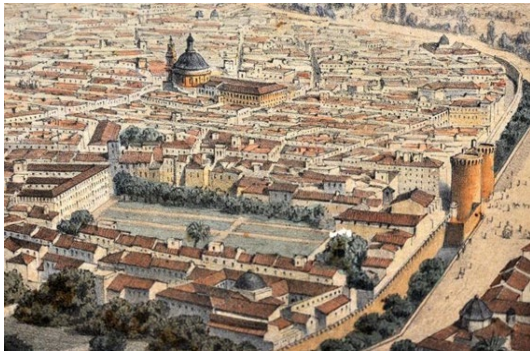
Fig. 3 - Detail of the view of Valencia where the volume of the Escuelas Pías in the city can be appreciated. Guesdon, 1832.

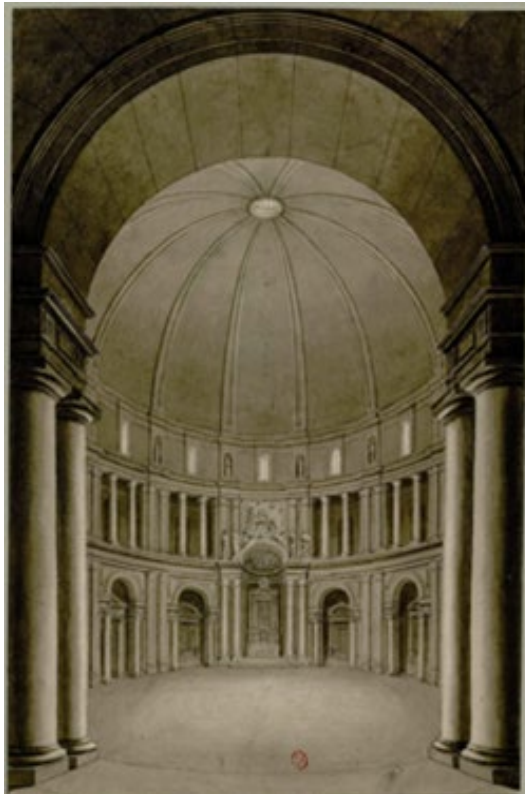
tablish that the damages in the model do not correspond to the actual cracking state that was established in the Master Plan. Masi, Stefanou and Vannuci (2018) study the cracks in the dome of Agrippa's Pantheon, performing a detailed three-dimensional simulation of finite elements, attributing the origin of the cracks to the contraction (shrinkage) of the concrete and the action of gravity by the different phases of construction of the opus caementicium. Gil Saura (2015) collects the information from the historical point of view of the collapse of some Valencian domes in the 18th century, without carrying out a constructive architectural analysis, nor

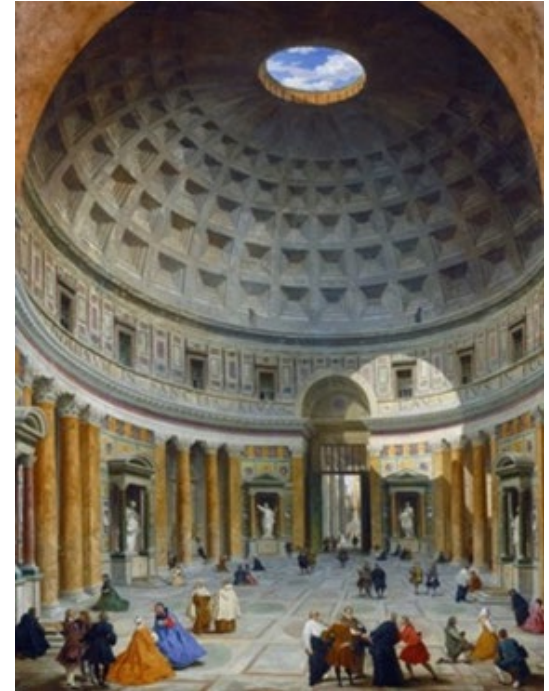
Fig. 6 - Sketch of Escuelas Pias for the Voyage pittoresque et historique de l'Espagne by Alexandre Laborde 1806-1820, François Ligier (left) and painting by Giovanni Paolo Panini of Agrippa's Pantheon (right), circa 1734.

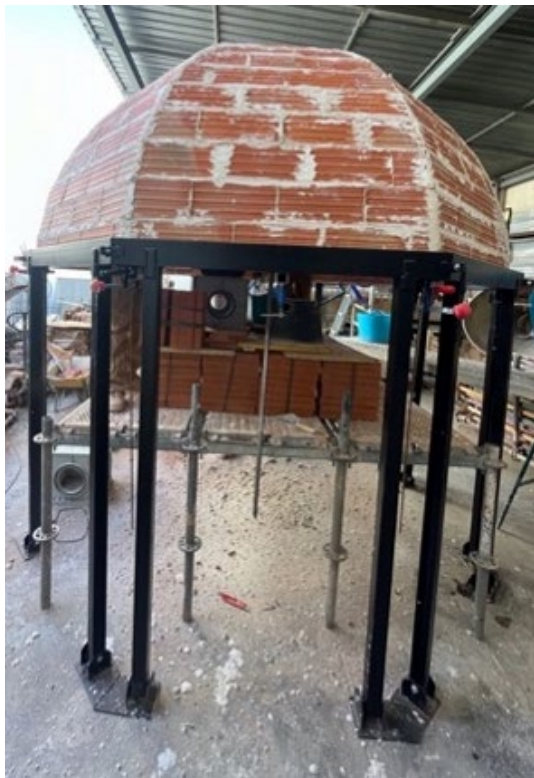
Fig. 8 - Real model built to test settlement cracks.

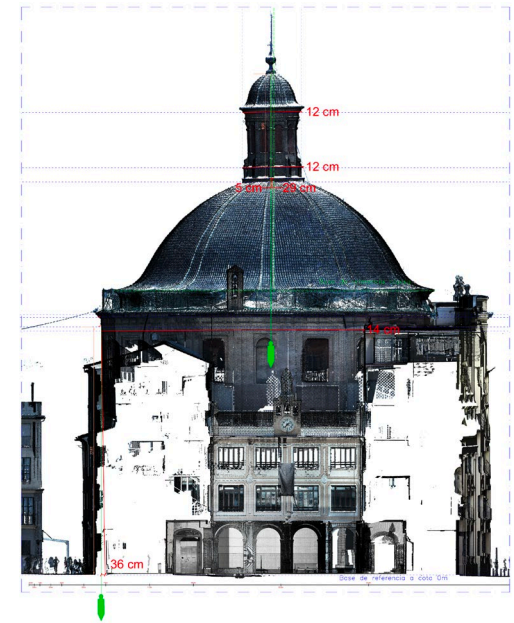
Fig. 13 - Interpretation of collapses of the alley's elevation and turns of the drum and lantern.
