## Drone survey for the documentation of degraded buildings

The paper presents the results of a survey campaign carried out on the church of Santa Maria della Purità in Giugliano in Campania, a fine example of Baroque sacred architecture built on the designs of the famous architect Domenico Antonio Vaccaro. The church has been closed to the public for 27 years due to the danger of falling portions of stucco and plaster, damaged by copious water infiltration, and has lesions on the intrados of the dome. On the extrados, on the other hand, portions of the covering's majolica tiles are missing, and vegetation is present. The survey therefore aimed to document both the geometry of the building, of which a recent survey was not available, and the deteriorating conditions of the structure and cladding. Due to the unsafe conditions limiting the stay inside the church, it was decided to use expeditious data acquisition procedures. The survey of the church of Santa Maria della Purità was carried out with the

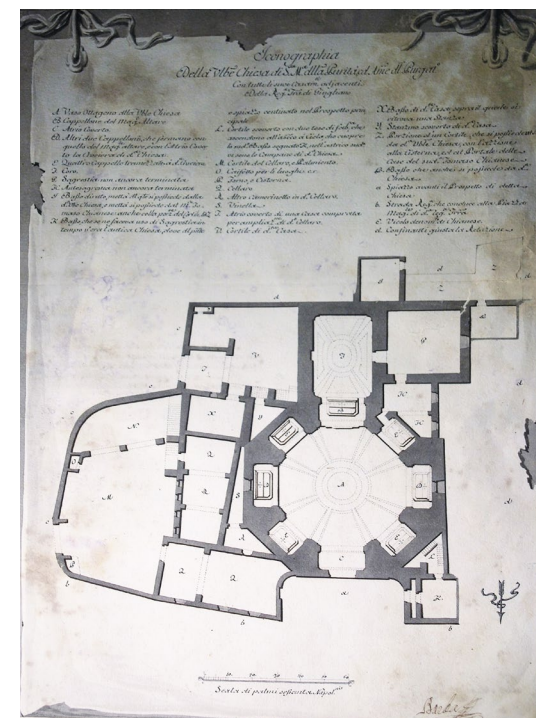
Fig. 2 - Domenico Gaetano Barba, plan of Santa Maria della Purità, 1763.

The Church of Santa Maria della Purità, also known as the Church of the Purgatory Souls, is a fine example of Baroque sacred architecture. It stands in Giugliano in Campania, with its façade facing north on Corso Campano (fig. 1). The priest Fabio Sebastiano Santoro, in his text “Scola di canto fermo...” of 1715, in which he also provides news about the churches and convents of Giugliano, ascribes the origin of the church to the practice of the faithful of praying to the Virgin of Purgatory at a votive aedicule in the place where the church now stands (Santoro, 1715). At the bases of the aedicule were arranged a multitude of souls of Purgatory, hence the church’s double name. This was erected thanks to donations collected from the faithful, based on a design by Domenico Antonio Vaccaro, one of the best-known architects of the Neapolitan eighteenth century, to whom is also attributed the design of the interior stucco work and the covering of the extrados of the dome. The model for the church design is the chapel of the Pio Monte della Misericordia in Naples, from which he took the octagonal plan on which the dome is grafted and the disposition of the side chapels. The foundation stone was laid in 1700, while the completion and inauguration of the church are dated to 1747 (Basile, 1800). Later, in 1765, the bell tower was erected, and the façade completed with the designs of the engineer Domenico Gaetano Barba, who also authored the historical plan that illustrates the church’s spaces and the surrounding areas and is valuable evidence of the geometry of the church at the date of 1763 (fig. 2).

The analysis of the historical plan shows that even at the time of its foundation, the church was surrounded by other buildings. The geometric shape on the plan, as confirmed by the survey carried out, is not a regular octagon, but rather the intersection of two Greek crosses. The one with the larger side is in axis with the entrance and the one with the smaller side is rotated at 45 degrees to it. The dome is set on the octagonal base and without a drum. It is lightened at the impost by eight large

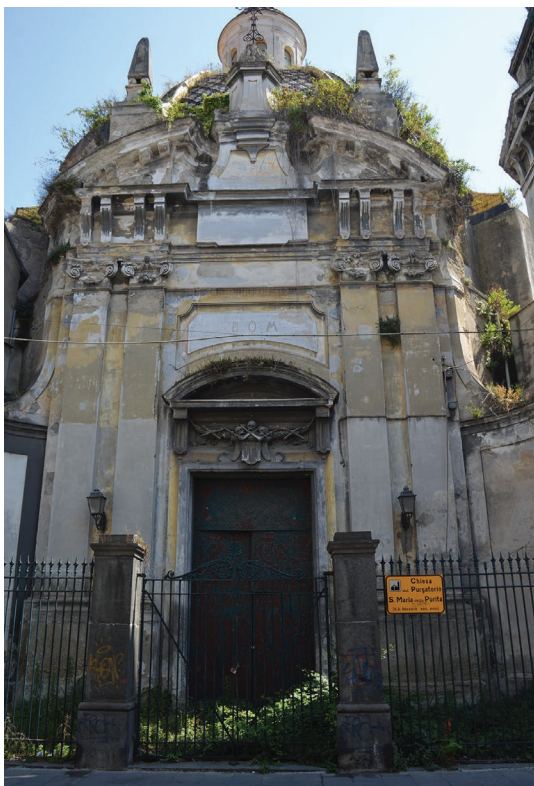
The church is in a state of deterioration caused by an absolute lack of ordinary maintenance (fig. 3), for which it was closed by order of the Fire Department in 2005 due to the danger of falling parts of stucco and plaster, and to this day access is still prohibited. Inside, cracks can be seen in the key at the intrados of the sections of the dome, due to the weakening of the masonry by copious water infiltration at the impost. It is evident that the masonry is impregnated with water in large portions, a phenomenon that combined with the presence of copious vegetation results in the crumbling and detachment of large portions of plaster and stucco, particularly during the rainy season and the subsequent drying phase of the masonry in the dry season. The cracks present on the surfaces of the sections of the dome, placed along its meridians, are probably caused by the cyclical settling of the tuff masonry, which, subject to the alternation of water infiltration and drying, is greatly affected by the physiological alternating movement of swelling and retraction. On the extrados of the dome, on the other hand, the lack of portions of majolica tiles replaced by a liner and the considerable presence of vegetation are noticeable (fig. 4). The façade also presents a high level of degradation due to the corrosive power of atmospheric agents and the smog of cars on the main street of Giugliano, resulting in the formation of moisture

Fig. 3 - Actual conditions of the church of Santa Maria della Purità. Photography by Mario Ronca.

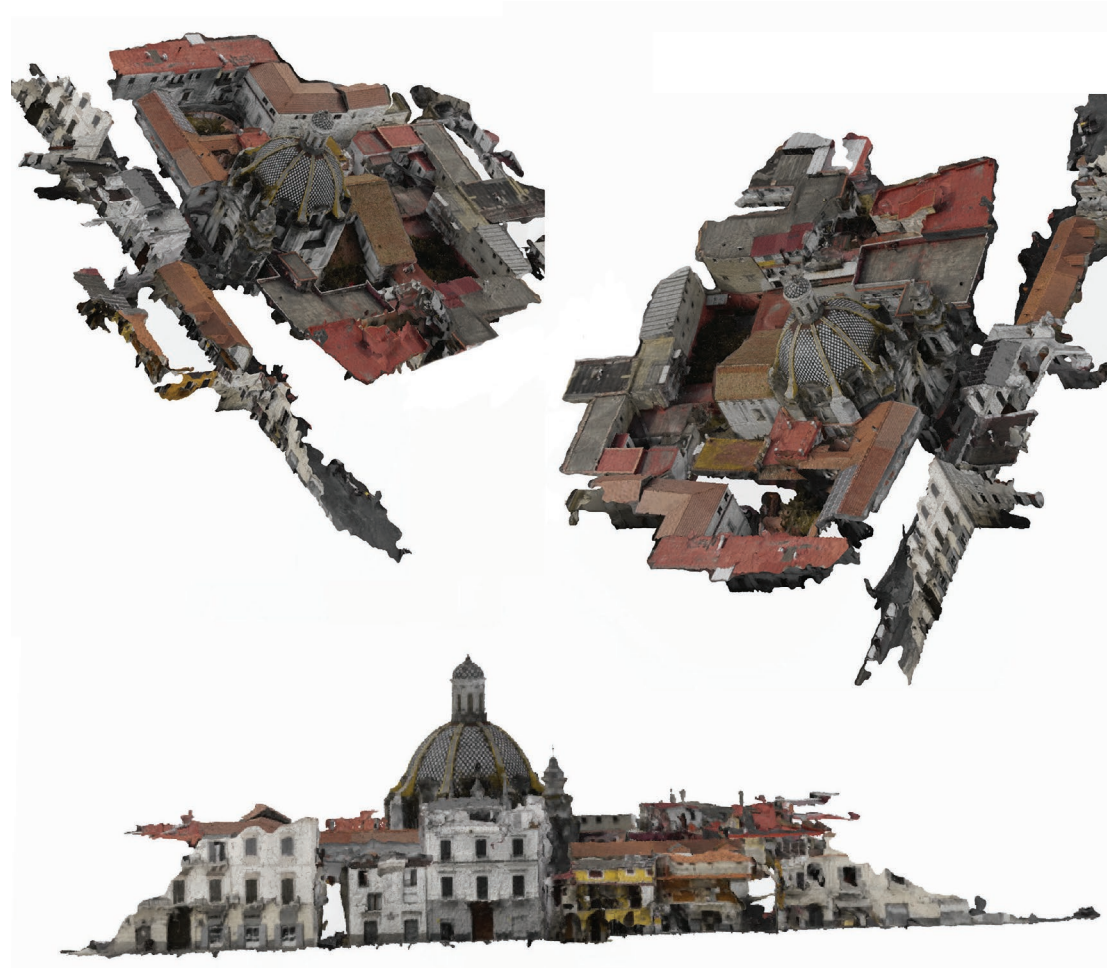
Fig. 6 - Views of the 3D model from the drone survey. Survey by Mario Ronca, supervisor Manuela Piscitelli.

the image fusion process, the software also eliminates the perspective deformation present in the images due to the low altitude at which the shots were taken. In addition, the drone's equipment with an internal GPS makes it possible to detect the spatial position and attitude of the camera at the time of the image capture, so that the subsequently processed orthophotos are georeferenced (Luhmann et al, 2014). Alternatively, the images can be georeferenced through ground control points with known geodetic coordinates. The model obtained through the drone survey provided information about the bell tower and the exterior of the church (fig. 6). The orthophoto obtained

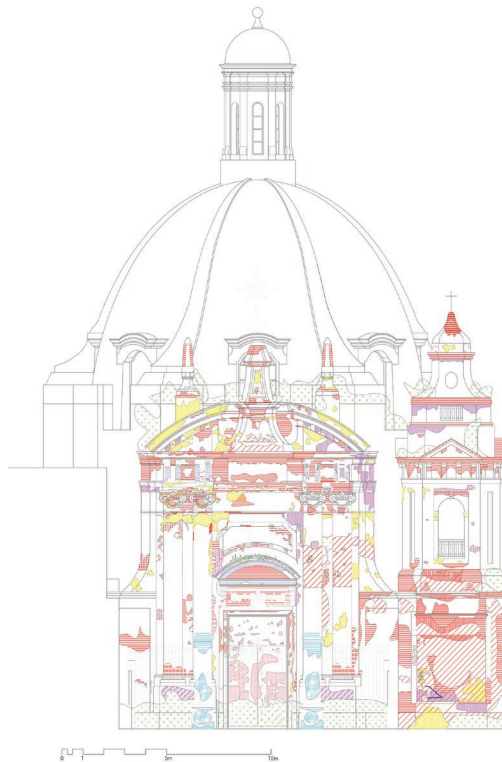
MATERIALE	DEGRADO	DESCRIZIONE	CAUSE	INTERVENTI
Tinteggiatura	Macchia	Alterazioni cromatiche dovute all'inquinamento atmosferico e all'azione delle piogge acide. Danneggiamento da inquinamento organico e inorganico, umidità, muffe, ruggine, microrganismi e virus.	-Inquinamento -Umidità -Inquinamento organico -Inquinamento inorganico -Inquinamento da Piogge e Acque acide	-Pulizie
	Deposito superficiale	Accumulo di materiali estranei di varia natura, quali ad esempio, polvere, fango ecc.	-Umidità -Inquinamento -Agenti atmosferici	-Pulizie
	Costura	Perdita di adesione per effetto del riscaldamento della aria in espansione. Tiroso ed anidride solforica. Inquinamento organico e inorganico. Muffe, ruggine, microrganismi e virus.	-Agenti atmosferici	-Pulizie
	Efflorescenza	Formazione di sali, generalmente di calcio, idrossido di sodio, cloruri di sodio, nitrati, solfati, fosfati, ecc. in superficie del manufatto.	-Agenti atmosferici -Umidità -Inquinamento organico	-Pulizie

Intonaco di Calce (Finitura)	Lacuna	Partito di continuità di supporto	-Sostanziosi -Presenza di materiali estranei	-No Integrazioni -Consolidamento
	Distacco	Soluzione di continuità tra strati 10' un intonaco, ad esempio, in presenza di granaio, alla caduta degli strati inferiori.	-Umidità -Inquinamento organico -Inquinamento inorganico -Agenti atmosferici	-No Integrazioni -Consolidamento
Intonaco di Calce (Arriccio)	Lacuna	Partito di continuità di supporto	-Sostanziosi -Presenza di materiali estranei	-No Integrazioni -Consolidamento
	Macchia	Colori e grafici scoloriti	-Inquinamento organico -Umidità -Inquinamento inorganico -Agenti atmosferici	-Pulizie -Consolidamento
	Erosione	Aggravamento di materiale sulla superficie dovuta a erosione di varia natura.	-Agenti atmosferici -Umidità -Inquinamento organico -Inquinamento inorganico	-Pulizie -Consolidamento
	Deposito superficiale	Accumulo di materiali estranei di varia natura, quali ad esempio, polvere, fango ecc.	-Umidità -Inquinamento -Agenti atmosferici	-Pulizie

Stucco	Macchia	Colori e grafici scoloriti	-Inquinamento organico -Umidità -Inquinamento inorganico -Agenti atmosferici	-Pulizie -Consolidamento
	Grafiti	Aggravamento superficiale dovuto a graffiti	-Agenti atmosferici	-Pulizie
Piperno	Deposito superficiale	Accumulo di materiali estranei di varia natura, quali ad esempio, polvere, fango ecc.	-Umidità -Inquinamento -Agenti atmosferici	-Pulizie
	Pietra	Deposito superficiale	-Umidità -Inquinamento -Agenti atmosferici	-Pulizie
Ferro	Corrosione	Formazione di ruggine e ossidazione, generalmente sotto strati di intonaco, dovuti all'azione delle piogge acide, all'umidità, all'inquinamento organico e inorganico, all'azione delle piogge acide, all'azione delle piogge acide, all'azione delle piogge acide.	-Agenti atmosferici -Umidità -Inquinamento organico -Inquinamento inorganico	-Pulizie
	Vegetazione	Presenza di vegetazione erbacea, arbustiva e arborea	-Agenti atmosferici -Umidità -Inquinamento organico -Inquinamento inorganico	-Pulizie -Consolidamento

Rapprezzo di malta cementizia	Aggravamento di materiale con presenza di ruggine e ossidazione, generalmente sotto strati di intonaco, dovuti all'azione delle piogge acide, all'umidità, all'inquinamento organico e inorganico, all'azione delle piogge acide, all'azione delle piogge acide.	-Agenti atmosferici -Umidità -Inquinamento organico -Inquinamento inorganico	-Pulizie -Consolidamento	
Fessurazione	Deposito superficiale	Accumulo di materiali estranei di varia natura, quali ad esempio, polvere, fango ecc.	-Umidità -Inquinamento -Agenti atmosferici	-Pulizie

Fig. 8 - Representation of the degrade conditions of the facade. Drawings by Mario Ronca, supervisor Manuela Piscitelli.

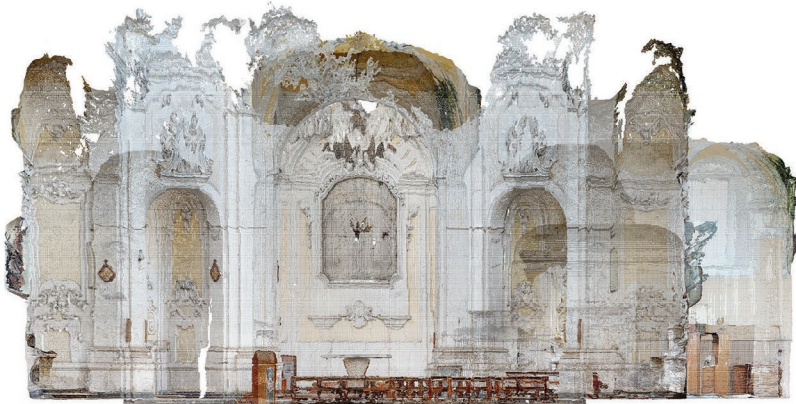
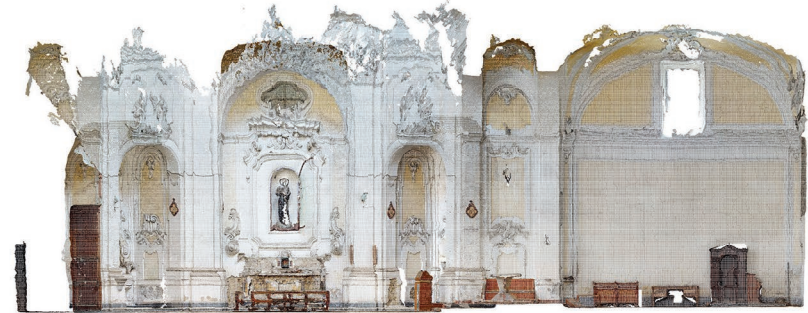
Fig. 10 - Point clouds of the interior sections of the church from the laser scanner acquisitions. Survey by Mario Ronca, supervisor Manuela Piscitelli.
