Drones for survey in the field of restoration: a multidisciplinary approach to the preservation of cultural heritage

The case study on which the methodology was tested is an ancient building located in Fisciano, Italy, namely the abandoned "Madonna del Fieno" chapel.

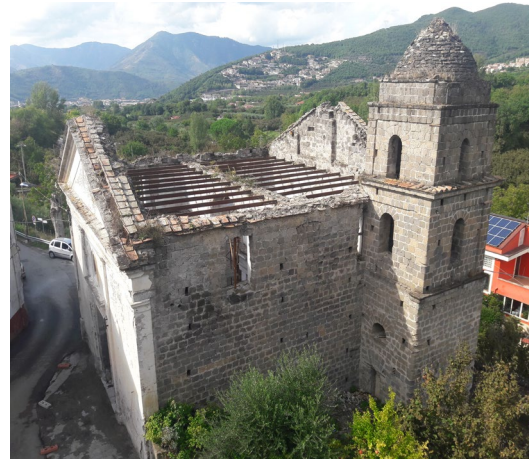
Fig. 2 - East facade of the complex

To meet the needs of a growing community it underwent several transformations over time. They mainly date back to the nineteenth century and regards the expansion of the church, the construction of a central partition, of a decorated ceiling and the modification of some openings. The Chapel turns out to be a sort of small hidden jewel, very close to the inhabited area, but at the same time not directly visible from the main roads, and, however, isolated from the rest of the surrounding buildings, with a splendid view over the valley and the rural landscape to the North (Fig.2).

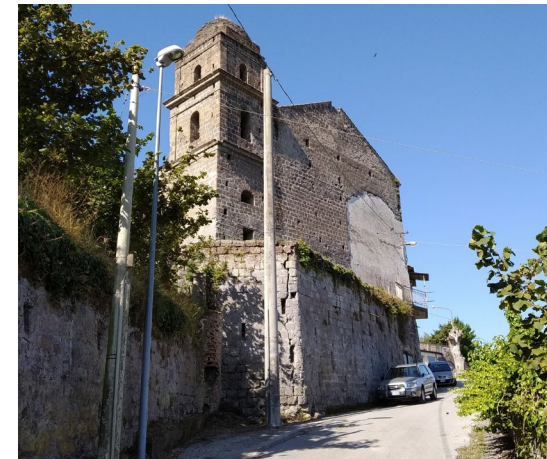
Fig. 3 - North facade of the complex

The complex can be divided into four parts: the Chapel, the bell tower, the rectory and the crypt. Each of these parts is located at a different altitude. In fact, between Via Cappella, which delimits the complex to the South, and Via Rio Secco, which delimits the complex to the North, there is a jump in height of more than 5 meters (Fig. 3).

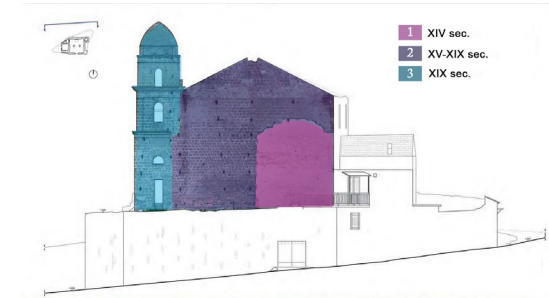
Crossing the archival and historical data with the information coming from the materic surveys it is possible to make a hypothesis regarding the historical evolution of the complex over the centuries and to divide the construction processes into 4 phases (Fig. 9).

Fig. 9 Reconstructive hypotheses of the main transformations of the complex

- XIV century: on the North and West elevations there are clearly visible traces of the first plant of the Church, which had a much smaller volume than the present one. On the North elevation the traces of the initial plant are visible thanks to the presence of a plastered part that corresponds to the North elevation of the old Chapel. Moreover, on the West elevation, it is visible the limit of the previous walls and an opening, now walled up, which was a window, having a lowered arch and a tuff frame. Both floors of the rectory house probably date back to the same century;

- XIX Century: the construction works carried out during the nineteenth century are numerous and give to the Church the actual conformation. The restoration that the Church underwent during this century was due to the damages suffered after the war bombings. First, the Chapel was entirely restored and internally decorated. The central partition is added, whose construction will involve the closing of the central openings on the East and West walls and the creation of new openings, symmetrical to the remaining ones. During this period, as well, on the North wall is positioned the altar, built in polychrome marble, and in correspondence of the entrance door is created a niche that still contains the decoration in majolica depicting the Virgin and Child with the Supplicants Souls, dated 1833. Further niches, still visible, are created at the sides of the altar, on the North wall, while others, created on the East and West walls, were then closed in the course of time, so, today, only the trace is visible. It is also possible to suppose that a pulpit and a choir, both made of wood, date back to the same period. Today they no longer exist, but it is possible to see traces of them on some points of the walls. The majolica

- XX Century: with the tragic earthquake that struck the Region in 1980, the Church suffered a series of damages and was completely abandoned for years. Especially, to make the Church unfit for use, is the collapse of large portions of the roof, both in the Chapel and in the rectory. Over time, the situation has become increasingly aggravated, giving way to an advanced state of degradation. In the summer of 2019 have been put in place by the locals of the cleaning and securing, thanks to which it was possible to remove much of the rubble and infesting vegetation. What was left of the roof and the ceiling of the Chapel has been completely removed, always for the purpose of pursuing the safety of the place, in fact are visible, today, only the iron girders of the old ceiling.
