Drones for survey in the field of restoration: a multidisciplinary approach to the preservation of cultural heritage

The case study on which the methodology was tested is an ancient building located in Fisciano, Italy, namely the abandoned "Madonna del Fieno" chapel.

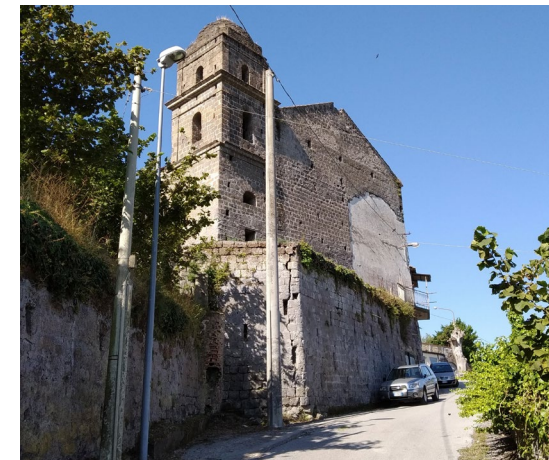
Fig. 3 - North facade of the complex

The complex can be divided into four parts: the Chapel, the bell tower, the rectory and the crypt. Each of these parts is located at a different altitude. In fact, between Via Cappella, which delimits the complex to the South, and Via Rio Secco, which delimits the complex to the North, there is a jump in height of more than 5 meters (Fig. 3).

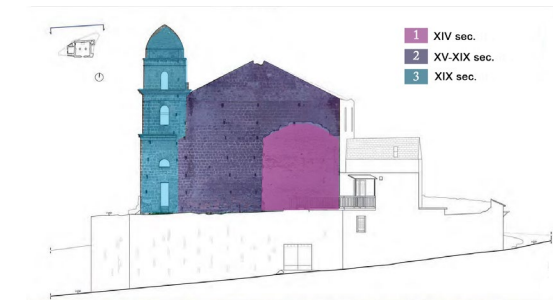
Fig. 7 - Elevation view of the main development phases of the church
