## **When the intervention on defensive walls connects with the cultural landscape. The Aljafería in Zaragoza, Spain**

This paper focuses on the analysis of the interventions carried out in the Palacio de la Aljafería (Aljafería Palace) in Zaragoza, Spain, as a reference in the practice of monumental restoration during the 20th century. Through a historical-critical methodology, based on the analysis of primary documentary sources (work projects and institutional reports) and secondary sources (specific bibliography of the historians and architects involved in the interventions), the main phases of intervention carried out on the monument between 1933 and 1985 are identified. From the study of the data collected, the conceptual framework is revealed through the technical and functional criteria that emerged from the reconstruction projects. This overview reveals a process of professionalization of the task of the architect-restorer in the period analyzed, as well as the existence of a certain tension between the necessary heritage conservation and functional

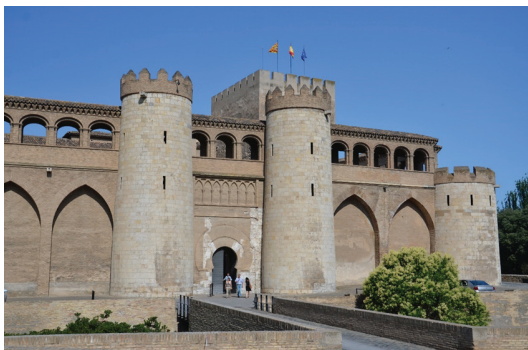
Fig. 6 - View of the main entrance to the Palacio de la Aljafería and the reconstructed bridge. Photograph: E. Bailliet (2012).

These interventions were part of a comprehensive vision of restoration, which not only sought to recover the architectural form of the enclosure, but also its historical significance as an Islamic and Christian defensive structure. The respectful reconstruction of lost elements, the integration of original remains, and precise graphic documentation made possible to return part of the Palacio de la Aljafería to its original configuration, contributing to its preservation as one of the most relevant examples of palatial and military architecture on the Iberian Peninsula. (Fig. 6).

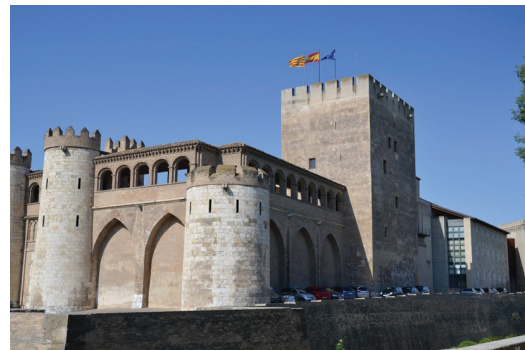
Fig. 7 - View Fig. 07. NE exterior view of the Palacio de la Aljafería. Photograph: E. Bailliet (2012).

In 1971, a new project was presented, focusing on the consolidation and reconstruction of the external walls. This project contemplated exposing the northeast corner of the enclosure, from the Main Gate to the Torre del Trovador. (Fig. 7).

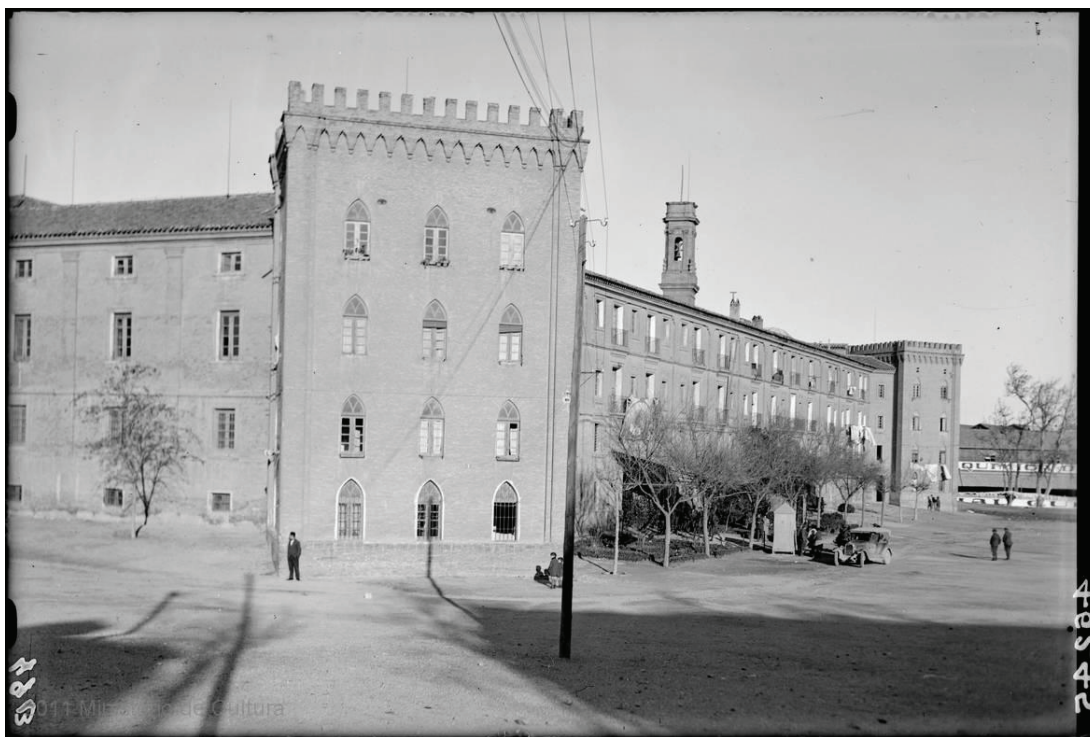
Fig. 8 - Tower to be demolished in the southeast corner. Photograph: Pando, A. (between 1932 and 1933). Source: LOTY Archive. Signature: LOTY-05244

The proposal was to dismantle the 18th-century tiled roof and replace the original roof top and crenellated walkway, following Spanochi's 1593 drawing. Furthermore, plans included the consolidation of walls and vaults, the demolition of added structures such as warehouses, and the construction of a new gallery with segmental arches, replicating those built by the Catholic Monarchs. (Fig. 8).

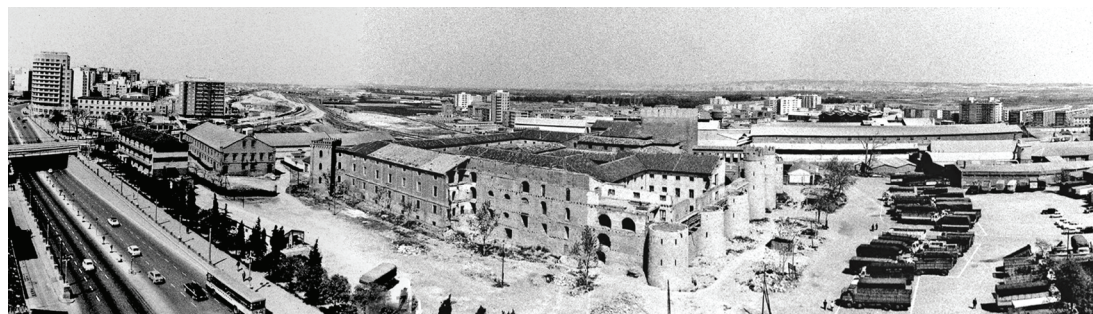
Fig. 9 - Panoramic view SE during the demolition of the barracks in 1973. Photograph: Gerardo Sancho Ramo. Great Archive of Ancient Zaragoza Project (GAZA)

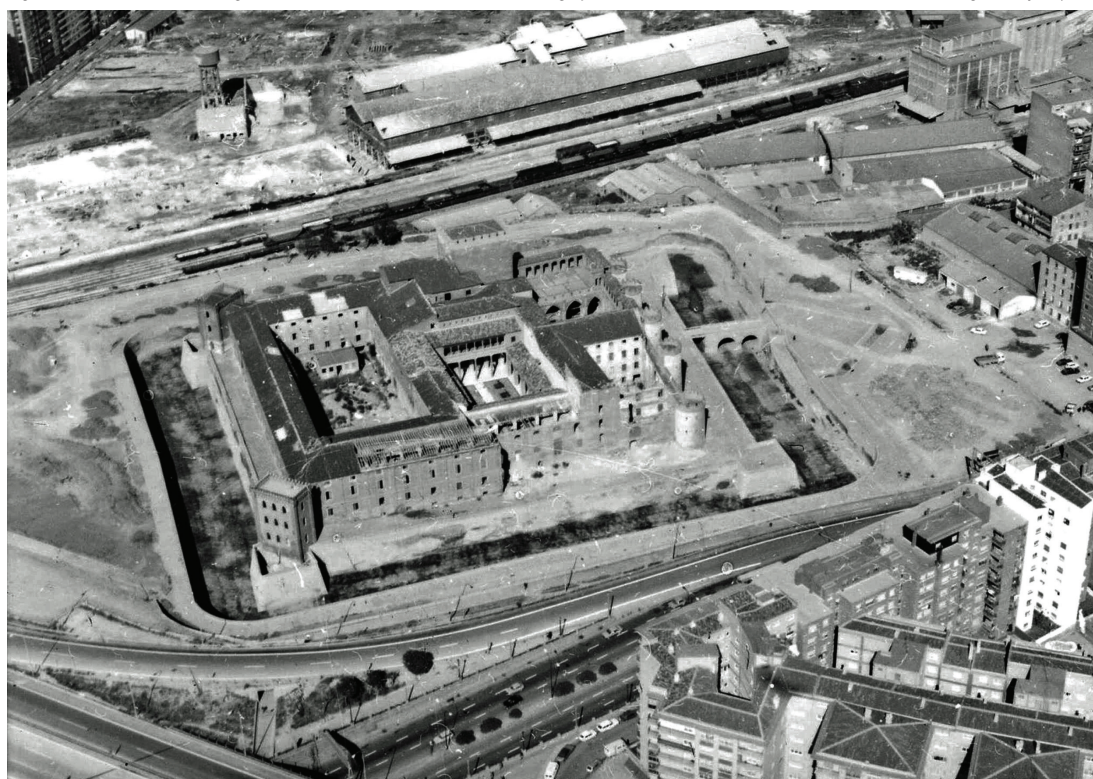
Fig. 10 - Panoramic view of the south during the demolition of the barracks in 1973. Photograph: José Luis Pomarón, in the Rafael Margalé Collection. Great Archive of Ancient Zaragoza Project (GAZA).

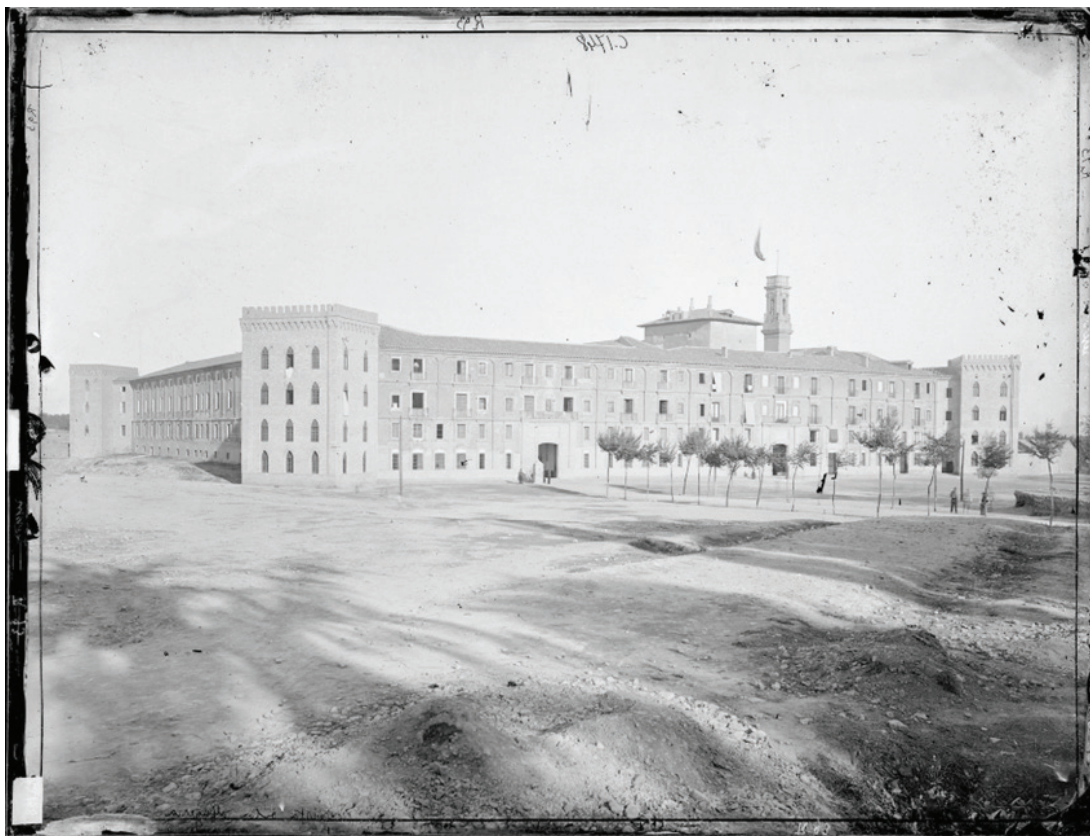
Fig. 13 - Southeast view of the Aljafería as a barracks. Photograph: Laurent, J. Ruiz Vernacci Archive, estimated date 1860-1886. Signature: VN-03539.

With the demolition (in 18th-century) of the castle's structures, its defensive nature was eradicated, and the palace itself was preserved, still bearing scars inside. In the confrontation between its defensive component and the Hispano-Muslim palatial residential structure, the latter triumphed, albeit with evident deterioration. (Fig. 13).

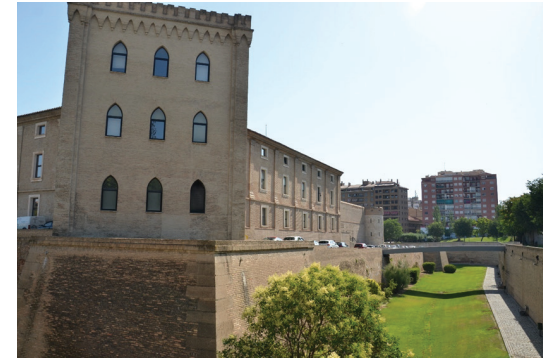
Fig. 15 - Southwest exterior of the Palacio de la Aljafería. Photograph: E.Bailliet. (2012).

It is worth noting that the adaptation process, which can be seen in the 2012 photographs accompanying this paper, reached the 21st century with the establishment of the Cortes of Aragon in the Palace, whose project was executed by architects Luis Franco and Mariano Pemán [7], in 2001. (Fig. 15).

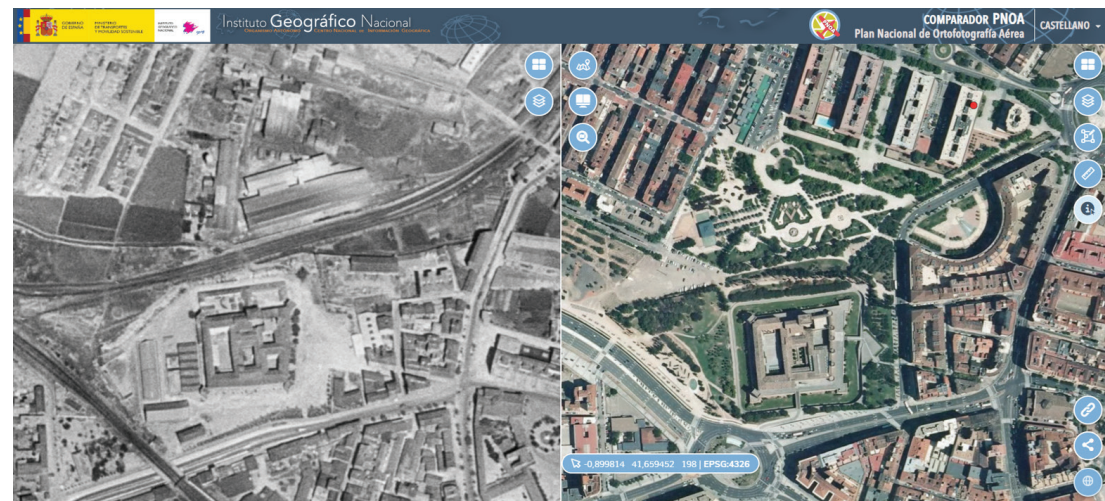
Fig. 14 - Capture aerial photographs, on the left, of the American flight (1956-1957) and, on the right, from 2012. Source: National Plan for Aerial Orthophotography Comparador (PNOA) of the National Geographic Institute (IGN) of the Ministry of Transport and Sustainable Mobility, Government of Spain.
