## ***The survey for conservation and the valorisation of rural villages of Central Sicily: the case study of Borgo Lupo in Mineo***

### **Il rilievo per la conservazione e la valorizzazione dei borghi rurali della Sicilia centrale: il caso studio di Borgo Pietro Lupo a Mineo**

*The essay, focusing on the study of Borgo Pietro Lupo in Mineo, Sicily, in all respects a small historical centre, intends to propose a pilot project for both its revitalisation and the functional and structural adaptation, based on a rigid documentation protocol and analysis, also carried out by innovative technologies. Through this case, the paper aims to highlight the role of the survey - the first essential step of the conservation process - in view of the prevention or reduction of seismic risk in areas exposed to the repetition of calamitous events. It seeks to show how imperative is that the cognitive moment be carried out by operators who, in addition to properly execute the measurement activities, have the technical and cultural baggage needed to 'read' and understand the architecture.*

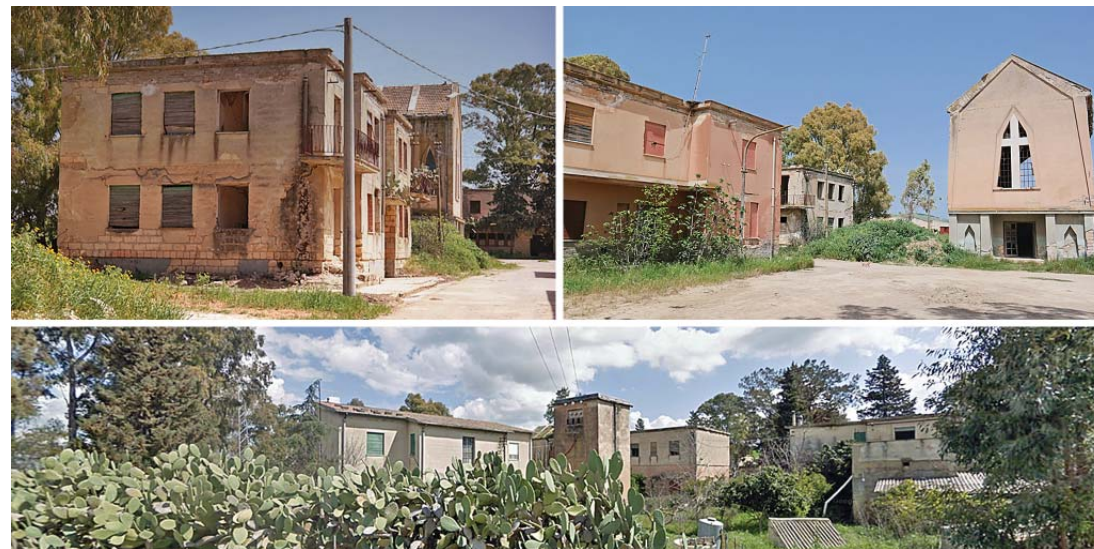
Fig. 2 - Today's pictures of Borgo Cascino in the municipality of Enna (photos authors).

These experiences have already concerned Borgo Antonino Cascino in Enna, Borgo Baccarato-Salioni in Aidone, Borgo Lupo in Mineo. The first has recently benefited from a recovery program thanks to a specific measure of the Community's structural funds and seems destined to become a kind of permanent display window for agri-food products in the area (fig. 2). The second is today a ghost town, as well as one of the twelve Sicilian rural villages, for which the Region has decided to proceed with the private alienation (fig. 3) as well as the third, only to a small extent occupied by a farm which has adapted some buildings to their own needs, after being literally vandalized by abusive residents (fig. 4).

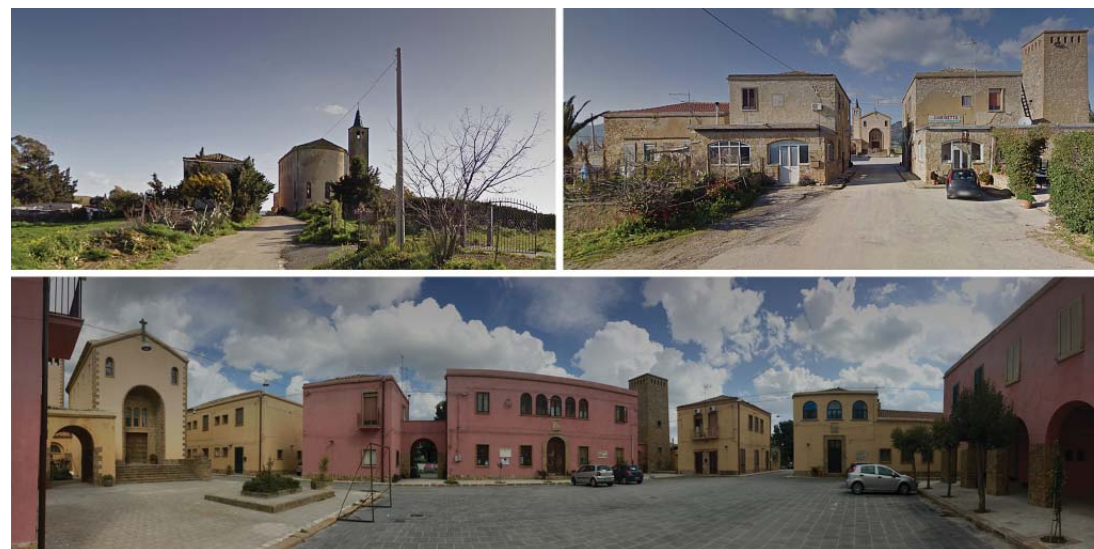
Fig. 3 - Current pictures of Borgo Baccarato in Aidone, province of Enna (photos authors).

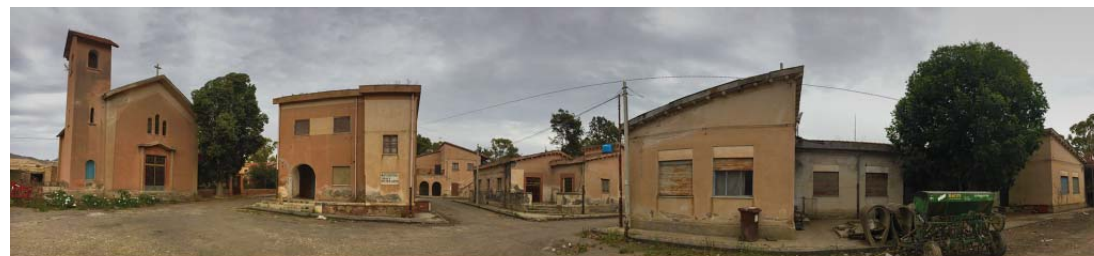
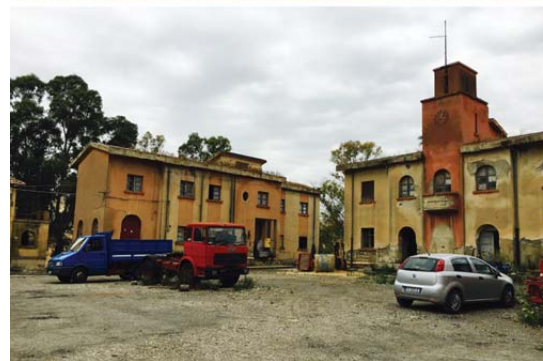
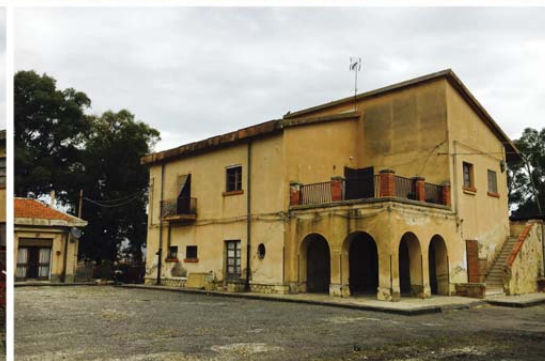
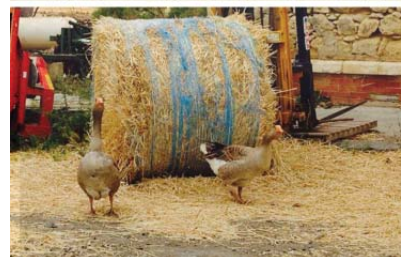
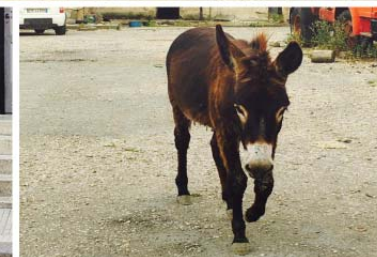
Fig. 4 - Borgo Pietro Lupo in Mineo, province of Catania, today (photos authors).

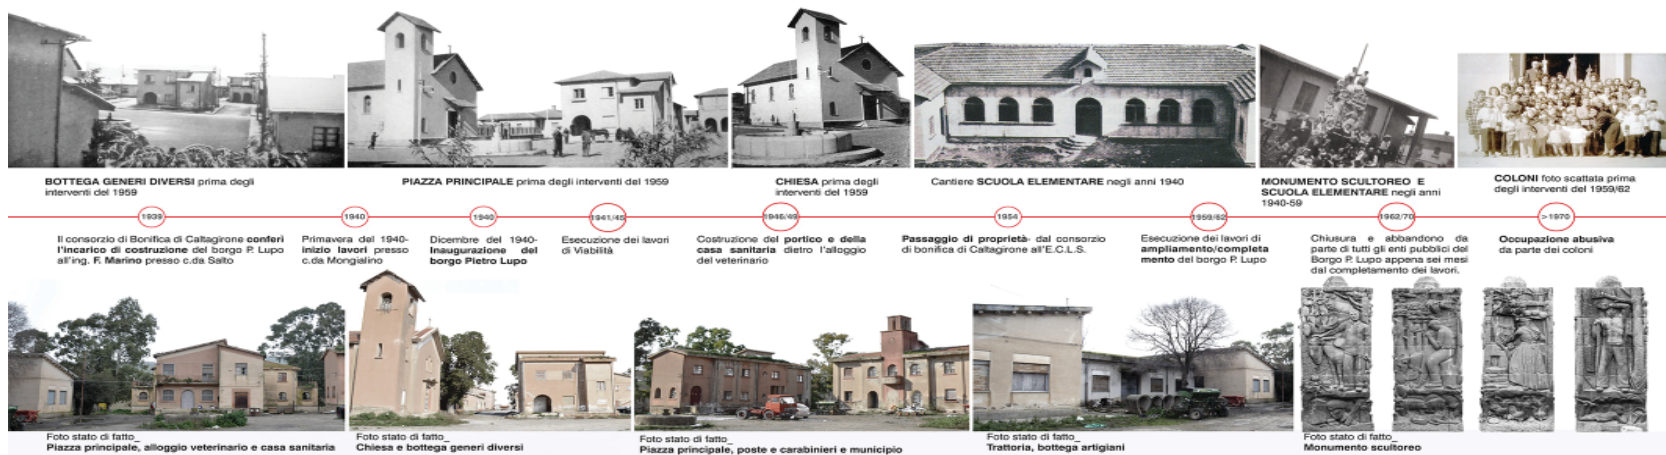
Fig. 9 - Borgo Pietro Lupo: a comparison between yesterday and today images and the reconstruction of the salient phases of its history.

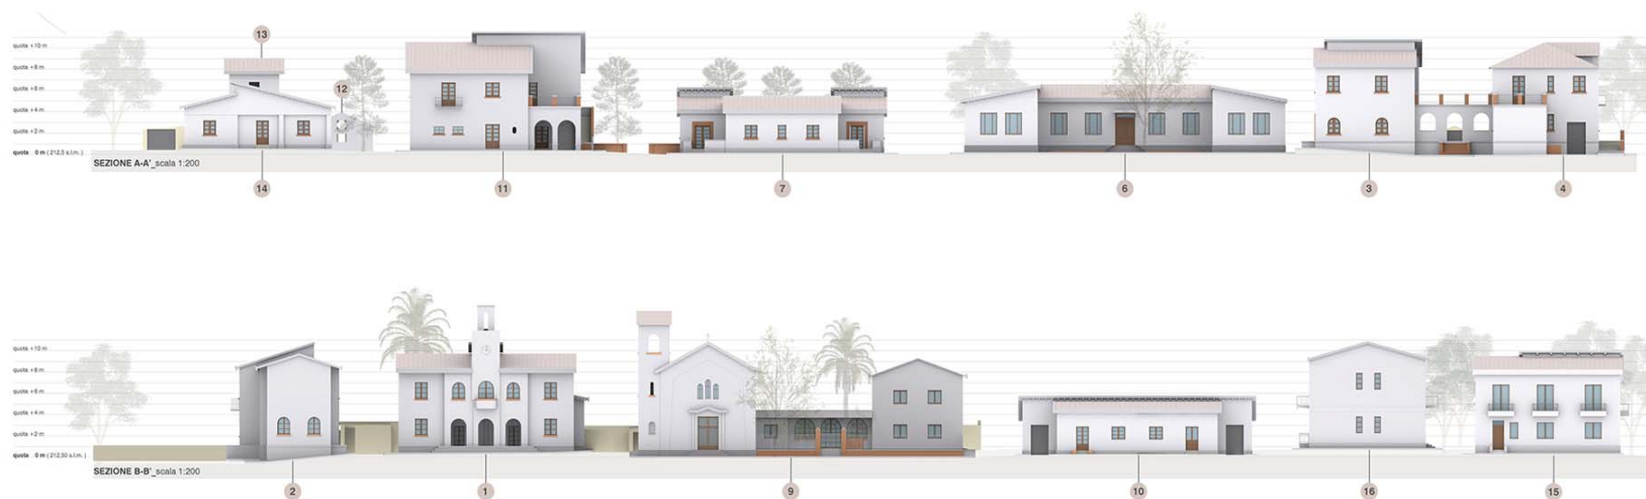
Fig. 11 - Rendering of some façades of the centre.

with the direct method, integrated with 3D laser scanning technology and 3D image-based reconstruction applications<sup>7</sup>. The production of a three-dimensional model (both discontinuous by points and continuous by mesh), the spatial projections and the graphic elaborations resulting from the methodological-operational apparatus developed by the conservation discipline (Cardaci et al., 2015) became the geometric structure for the identification, study, representation and cataloging of matter as well as for the recognition of alterations and critical factors (fig. 11).

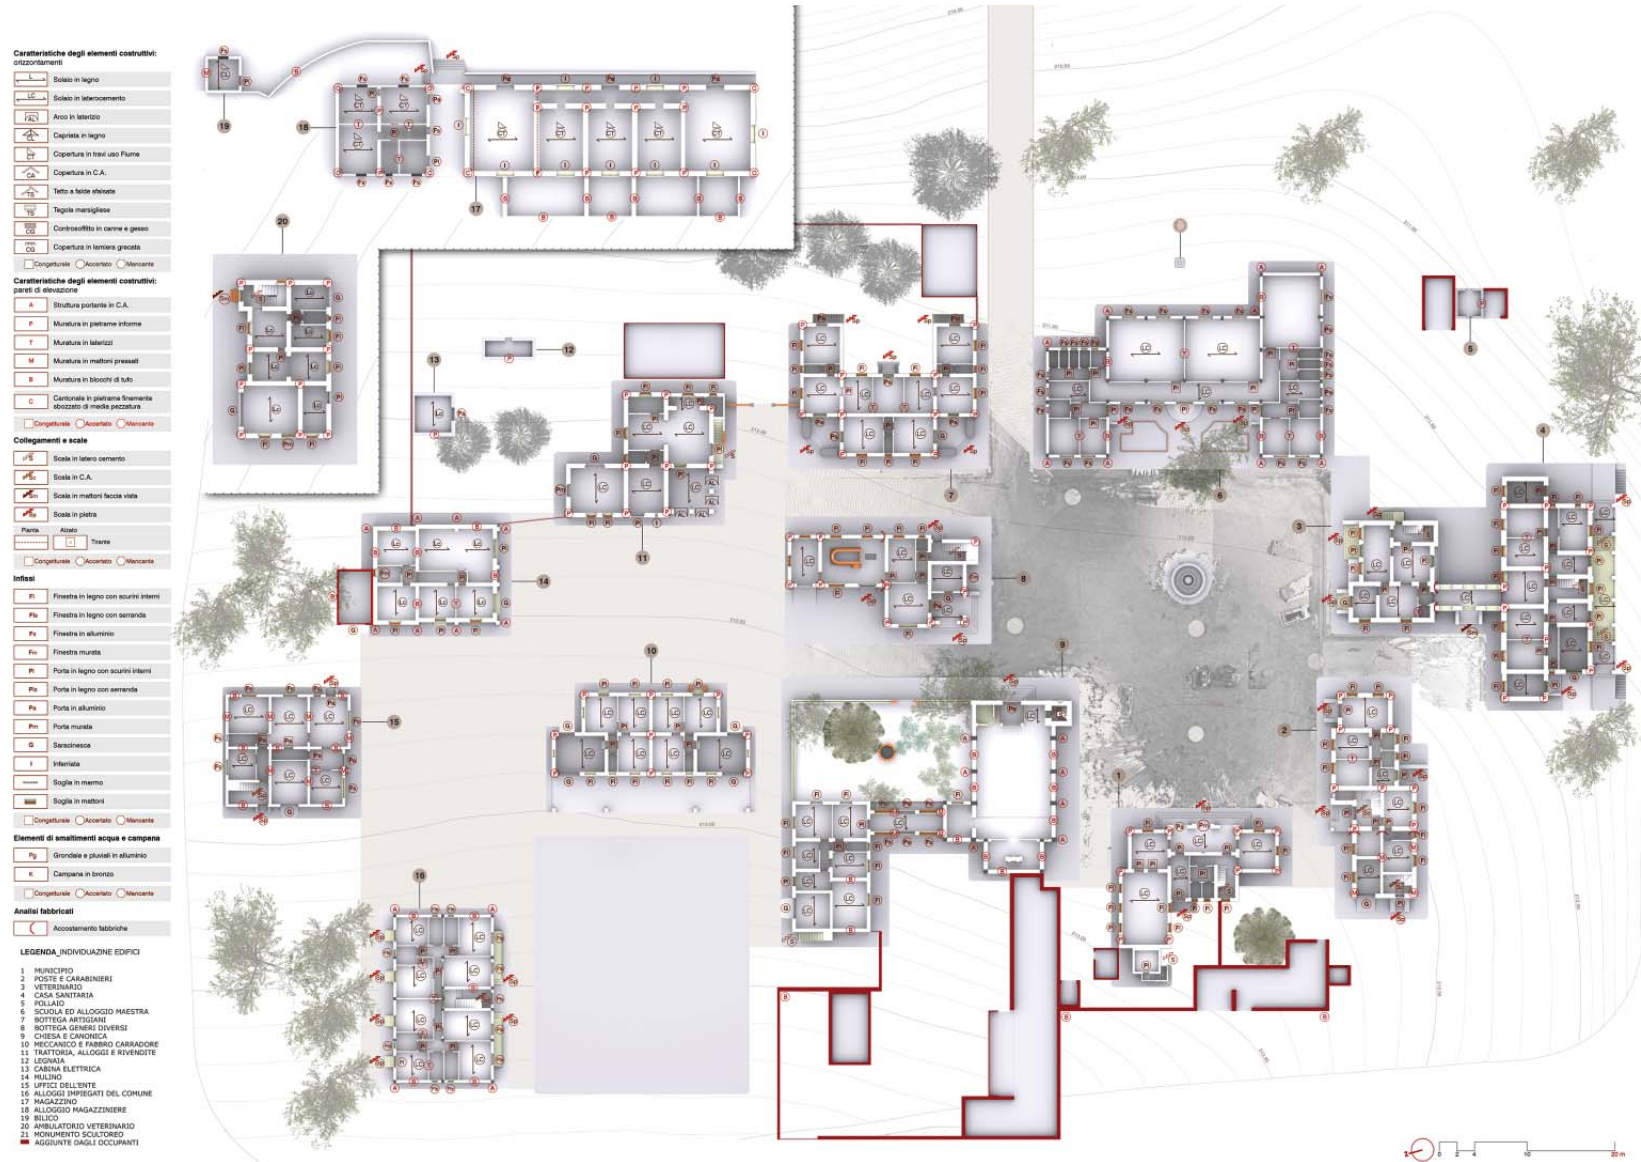
Fig. 12 - The graphic rendering of the ground floor plans with the indication of the functional distribution and the technical-constructive characteristics of the whole village.

The 'material and constructive-structural survey' has been addressed to the overall reading of the materials and construction techniques used, as well as to carry out a punctual study of the resistive elements, aimed at identifying the structural pattern. It has seen the formulation of specific mapping on scale 1:50 dedicated to the recognition, the evaluation of the quality and the state of preservation of materials and constituent elements, the realization of abaci, the systematic and schematic analysis of frames and masonry, floors, roofs and connections. All elements which were observed from the inside by the operator (Giuffré, 1993), through

direct survey, small essays and non-destructive indirect investigations (thermography, etc.) also to verify their correspondence with the best practice (fig. 12).

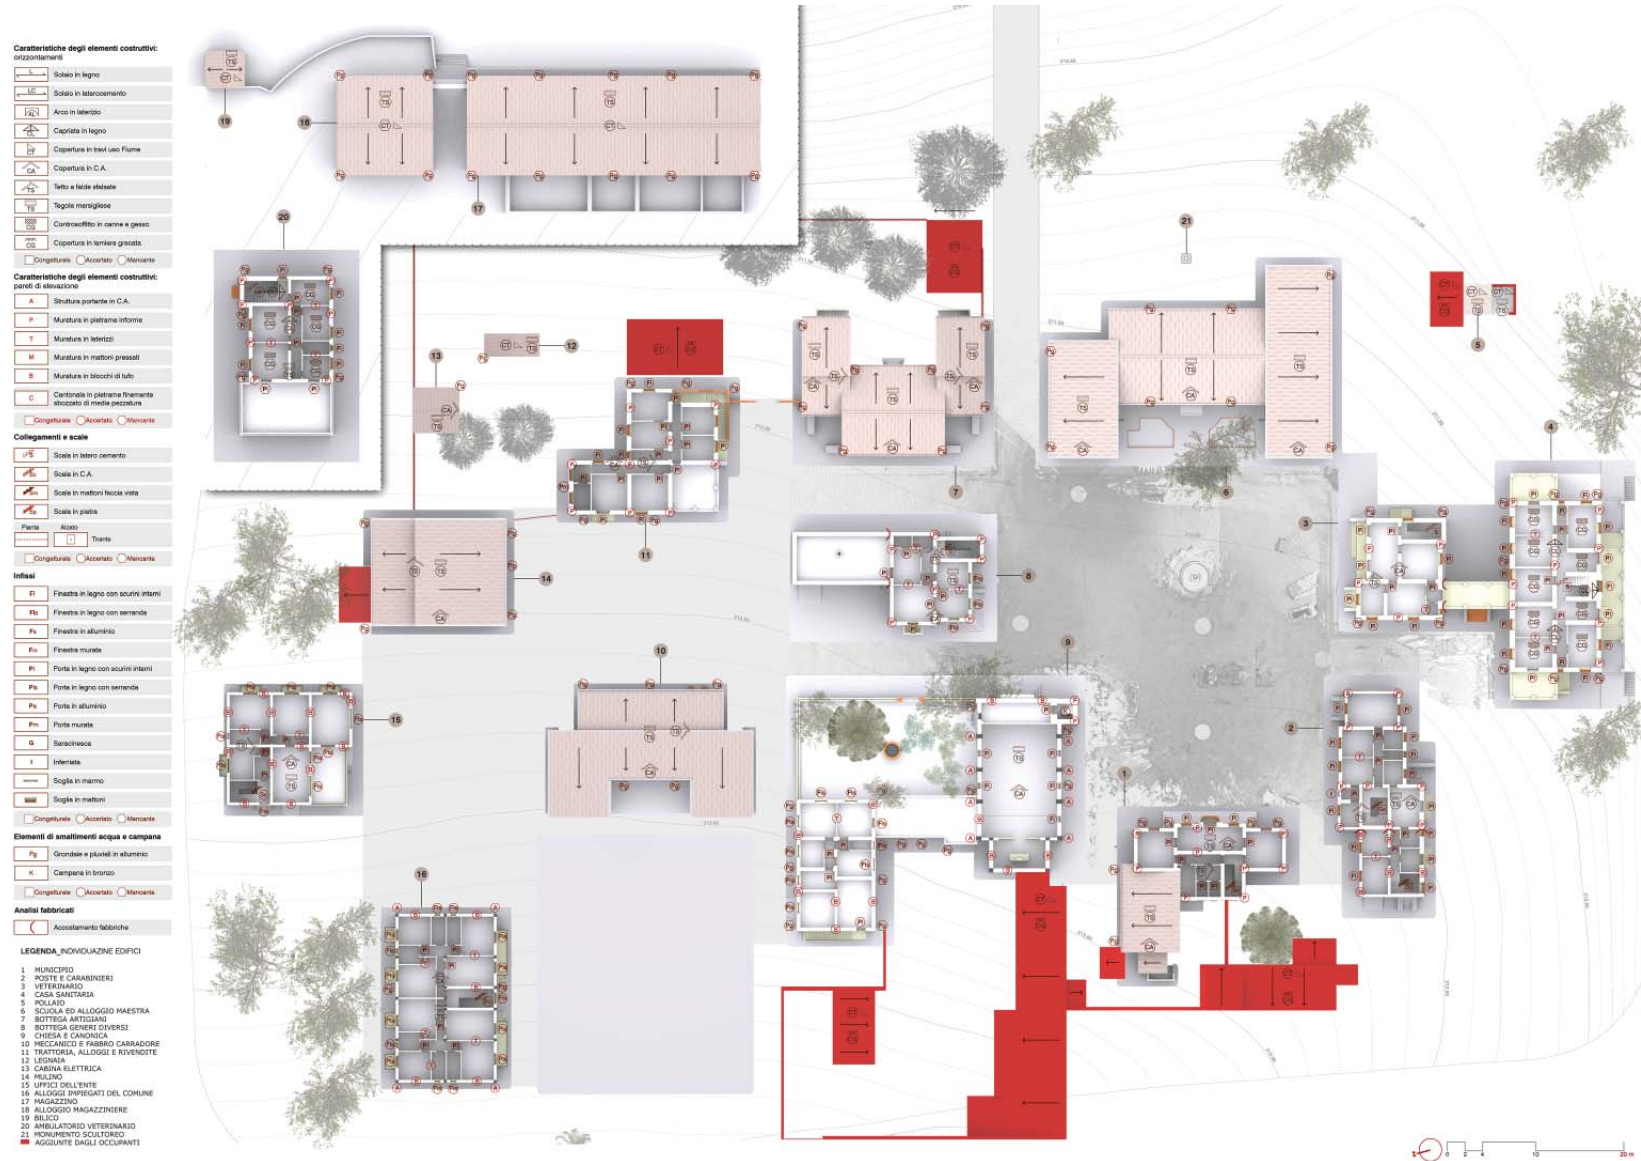
Fig. 13 - The graphic rendering of the first floor plans with the indication of the functional distribution and the technical-constructive characteristics of the whole village.

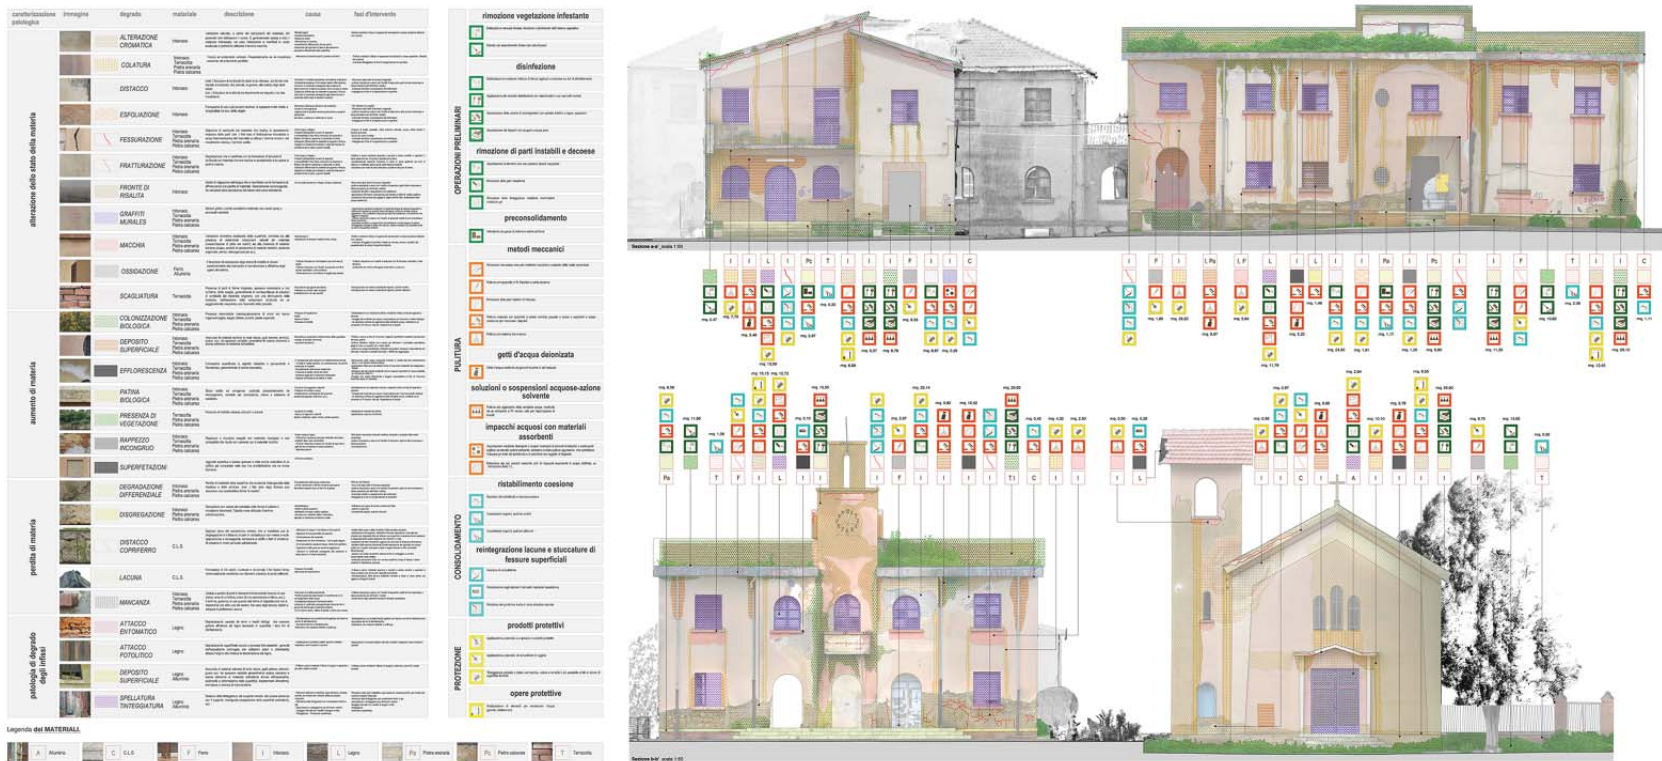
Fig. 14 - The material-pathological survey with the indication of conservation interventions.

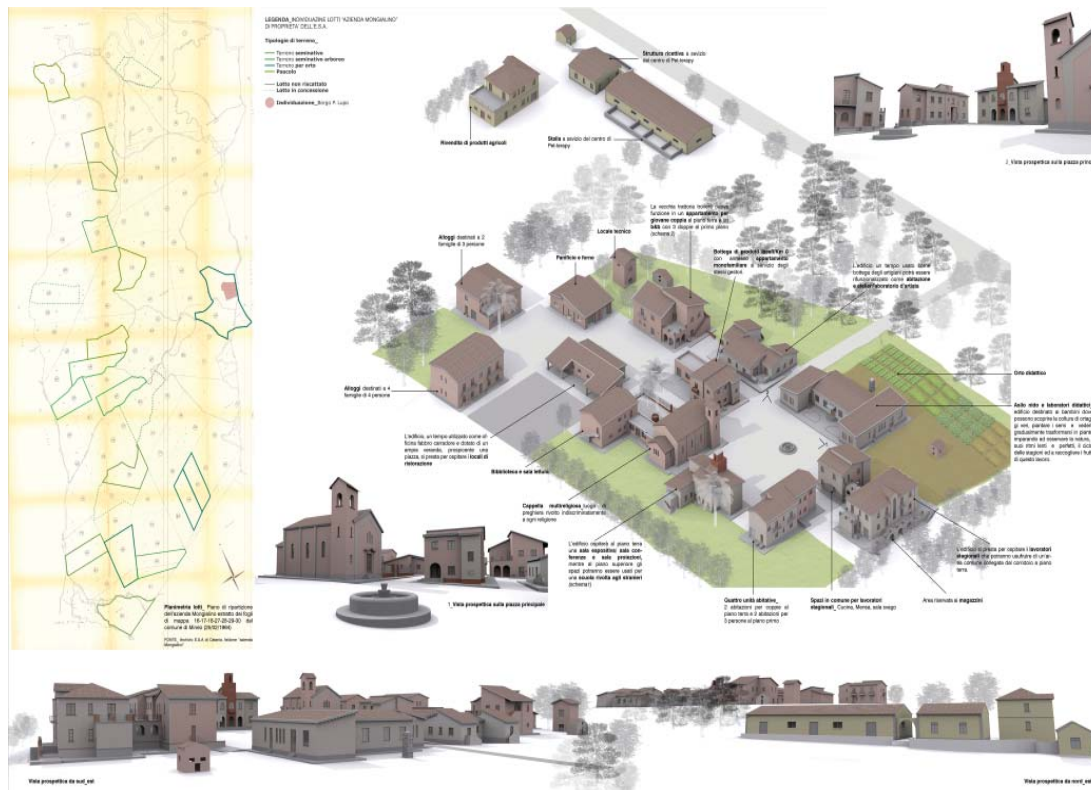
Fig. 17 - Design of the reuse project.
