The Disappeared Archbishop's Palace of Burgos: a graphic reconstruction

Keywords:
Architectural heritage; Gothic; Burgos Cathedral; Unesco; Graphic reconstruction

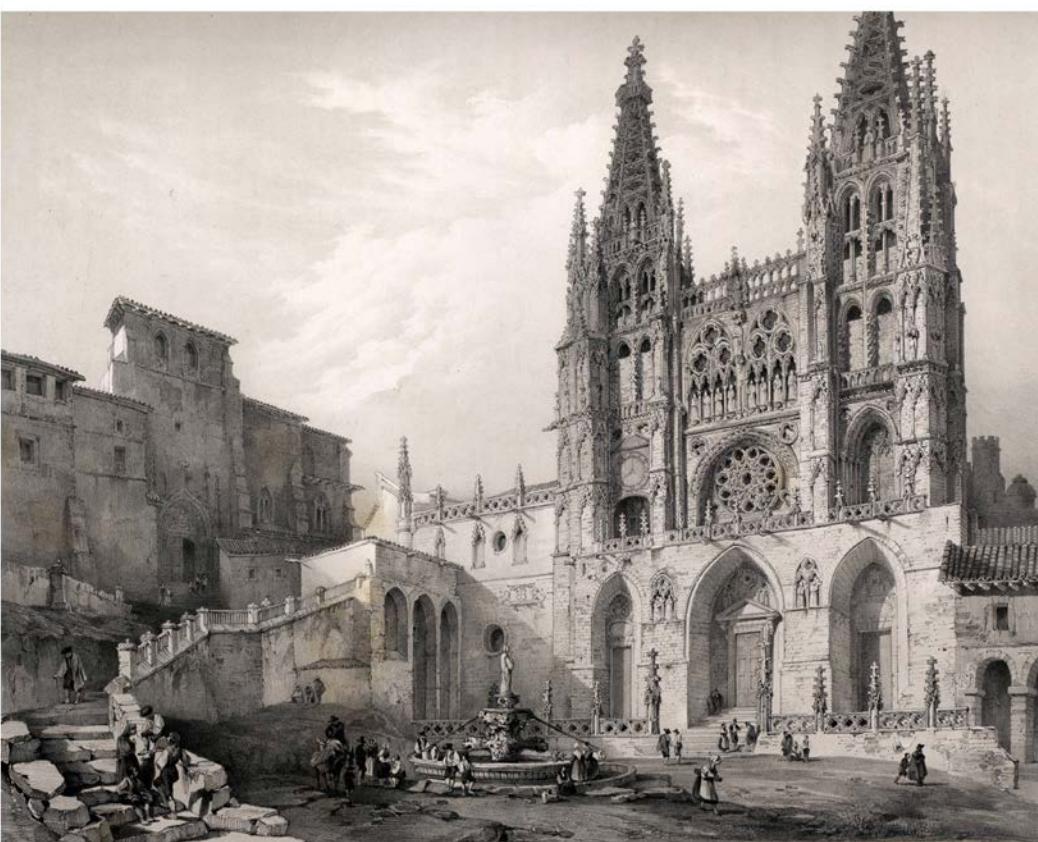
Fig. 1 - Engraving of the Cover of Santa María of the Cathedral of Burgos. 1842-1850. Author: Genaro Pérez de Villa-Arnil. Source: artistic and monumental Spain. Volume II.

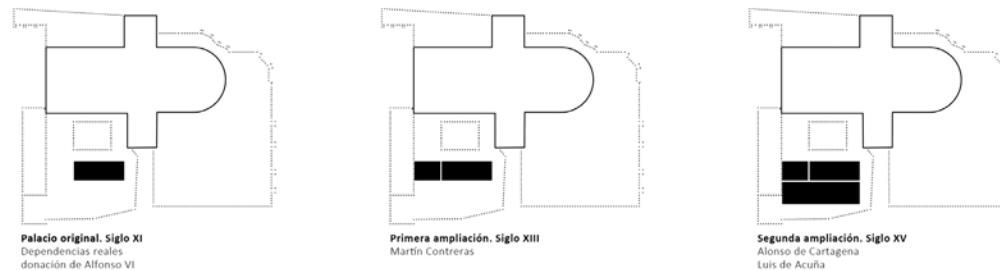
Fig. 3 - Growth diagrams of the Archbishop's Palace, (from left to right) original state to the extensions of Martín Contreras, Alonso de Cartagena and Luis de Acuña. Own elaboration.

p. 444). The monumental endeavor failed to be carried out and the palace continued to host further dwellers (fig.3).

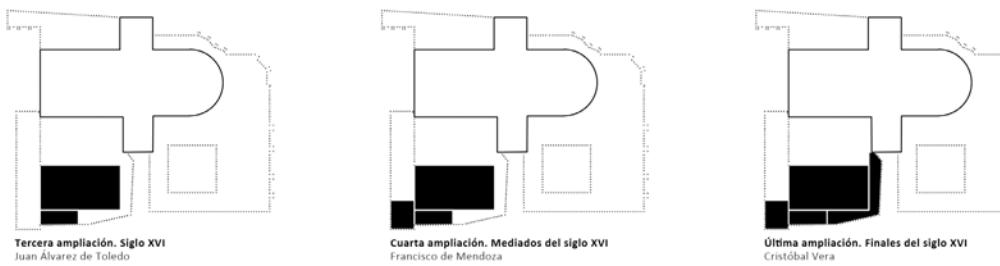
Fig. 4 - Growth diagrams of the Archbishop's Palace, (from left to right) Juan Álvarez de Toledo, Francisco de Mendoza and Cristóbal Vela. Own elaboration.

the palace. This intervention resulted in a singular corner, ground-plan volume, square ground plan on the way to Lencería Street. Finally, once the Burgos see was elevated to archdiocese by Pope Gregory XIII, Archbishop Cristóbal Vela finished the building in 1590. In the last enlargement, the angular annex exceeded the alignment with the gothic cloister and invaded a large part of the façade and the Sarmental stairway. (Martínez y Sanz, 1866, p. 156) (fig.4).

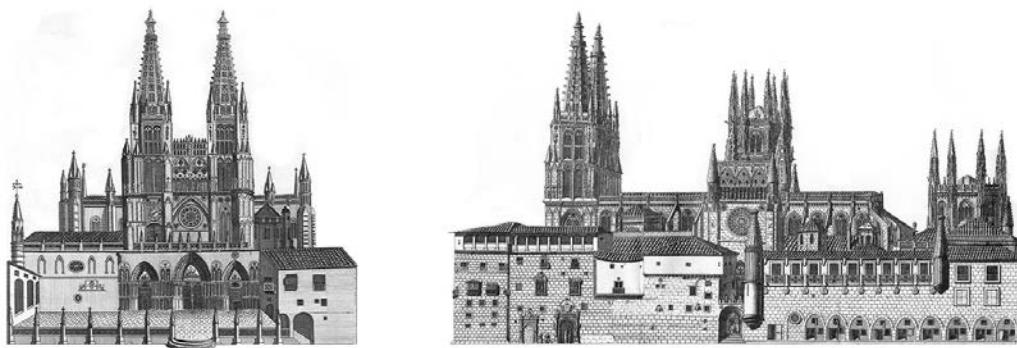
Fig. 5 - West elevation and south elevation of the Cathedral of Burgos in the 18th century. Source: FLÓREZ, Enrique: Sacred Spain. Volume XXVI. Madrid: Office of Antonio Marín, 1771.

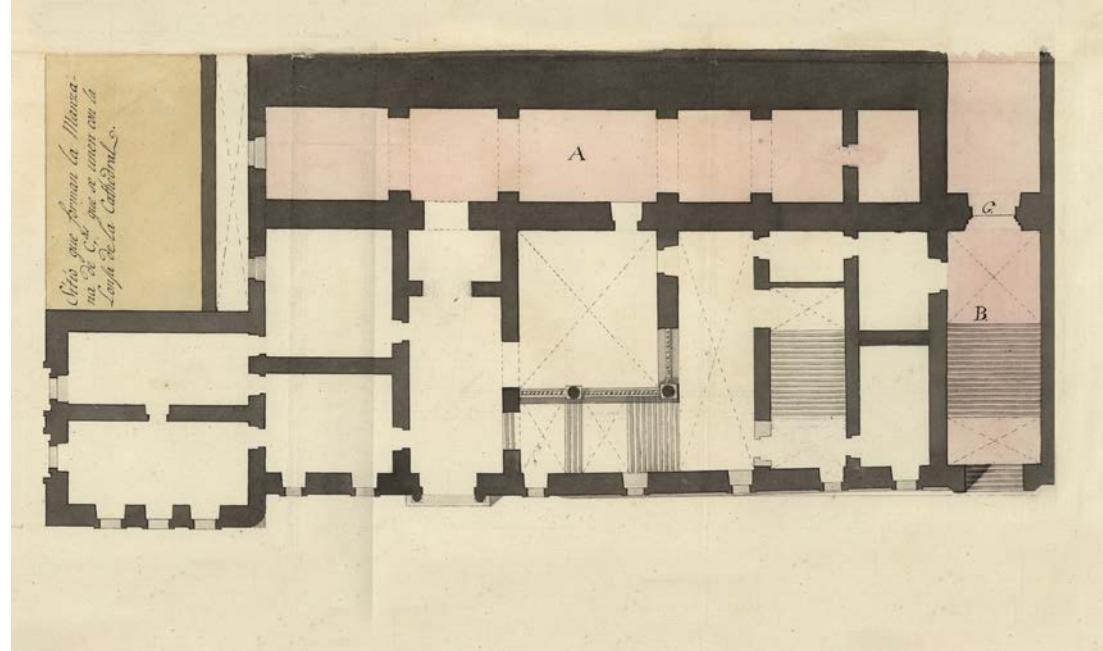
Fig. 6 - Proposal by Pedro Regalado de Soto for the ideal composition of the Palace after its restoration, 1816. Real Academia de Bellas Artes de San Fernando, signature: 2-29 / 3.

Pedro Regalado de Soto indicated [9] that "only a part of the interior of the Archbishop's Palace had to be repaired and reformed" as a result of the fire but did not deem the building to be in risk of collapse. Despite the above, he pointed out the need for some interventions aimed at harmonizing the building and repairing it. [10] He also pointed out interior reforms meant for its use, for which he presented an idealized drawing (fig.6).

[10] Pedro Regalado proposed lowering the height of the building and aligning the cornices of the roofs, walling up and harmonizing various openings and projections, as well as repairing the cracks and different armor.

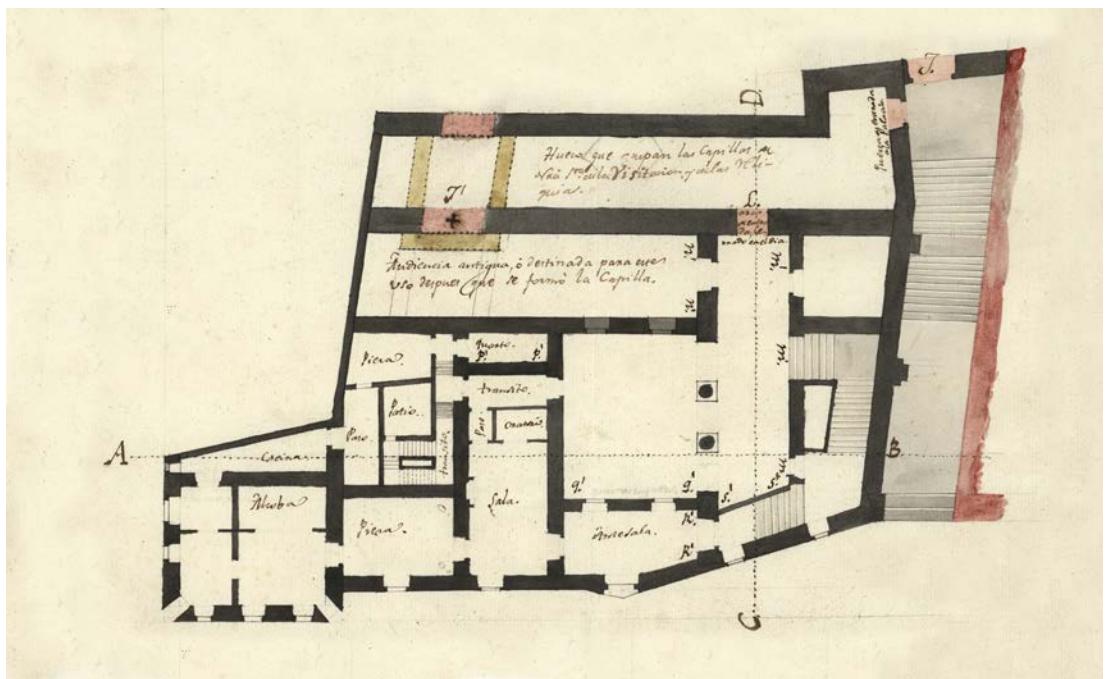
Fig. 7 - Raising of the Archbishop's Palace by Joaquín Ignacio de Zunzunegui in 1817. San Fernando Royal Academy of Fine Arts, signature: 2-29 / 3.

[11] Joaquín Ignacio de Zunzunegui presented on April 28, 1817, in addition to the aforementioned report, six drawings in which he collected the poor condition of the building. RABASF 2-29 / 3 Plans 1 to 6

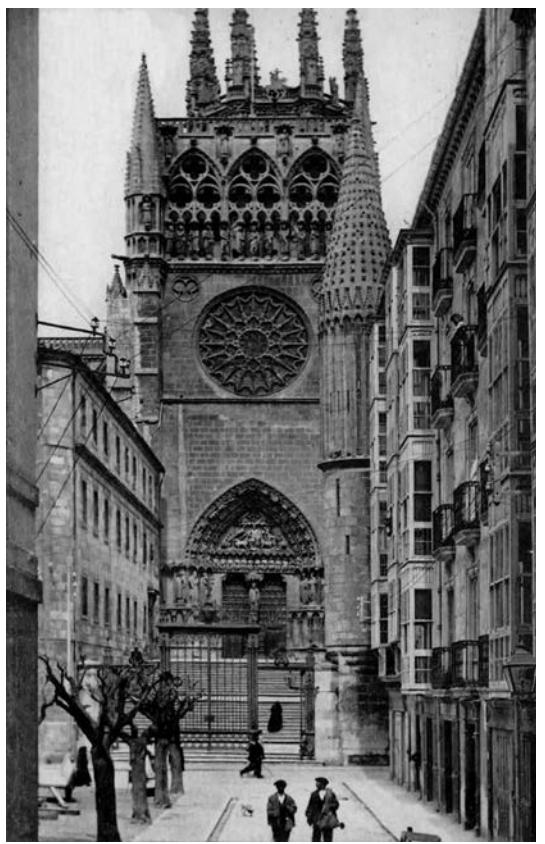
Fig. 9 - General view of the Sarmental's gate after the demolition of the east bay of the palace, where the regularized layout and composition of the new façade and the access railings to the widened staircase can be appreciated. Photograph of the Phototype of Hauser and Menet, Madrid. Source: Digital Library of Castilla y León, symbol: 726.6 (460.182 B).

which went on for a long time, [13] resulted in a lengthened space from the side façade of the Archbishop's Palace, -upon which a longing for demolition lingered on -[14] to the façade of the former Colegio de San Gerónimo, where the new Archbishop's Palace was meant to be placed (fig.9).

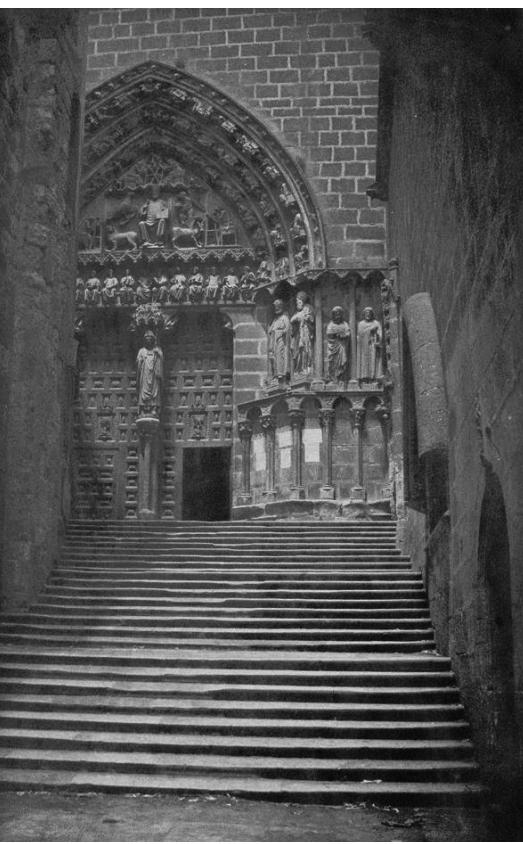
Fig. 10 - The photograph by the German Oppenheim, in which the Sarmental Gate can be seen partially hidden by the eastern façade of the Archbishop's Palace. August F. Oppenheim, 1852. Source: Ministry of Education, Culture and Sports, Historical Heritage Photo Library. symbol: SB-0134. There is a similar photograph taken by Charles Clifford of the Puerta del Sarmental of the Cathedral taken in 1853. Madrid Memory digital library. symbol 34491-18.

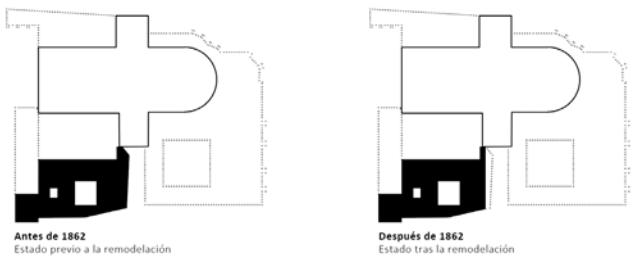
Fig. 12 - Explanatory diagrams of the intervention in the mid-nineteenth century in the Archbishop's Palace. Own elaboration.

After the appointment of Archbishop Manuel Gómez-Salazar in 1886, both sides seemed to bring their approaches closer on the question of the South side of the temple. In the words of the Mayor, the Bishop "was willing to hand over the Archbishop's Palace for the purpose of the Cathedral's beautification" [17]. However, the possibility vanished upon the Bishop's sudden death. The new Bishop, Franciscan Gregorio María Aguirre, curbed the city council's ambitions (fig.12).

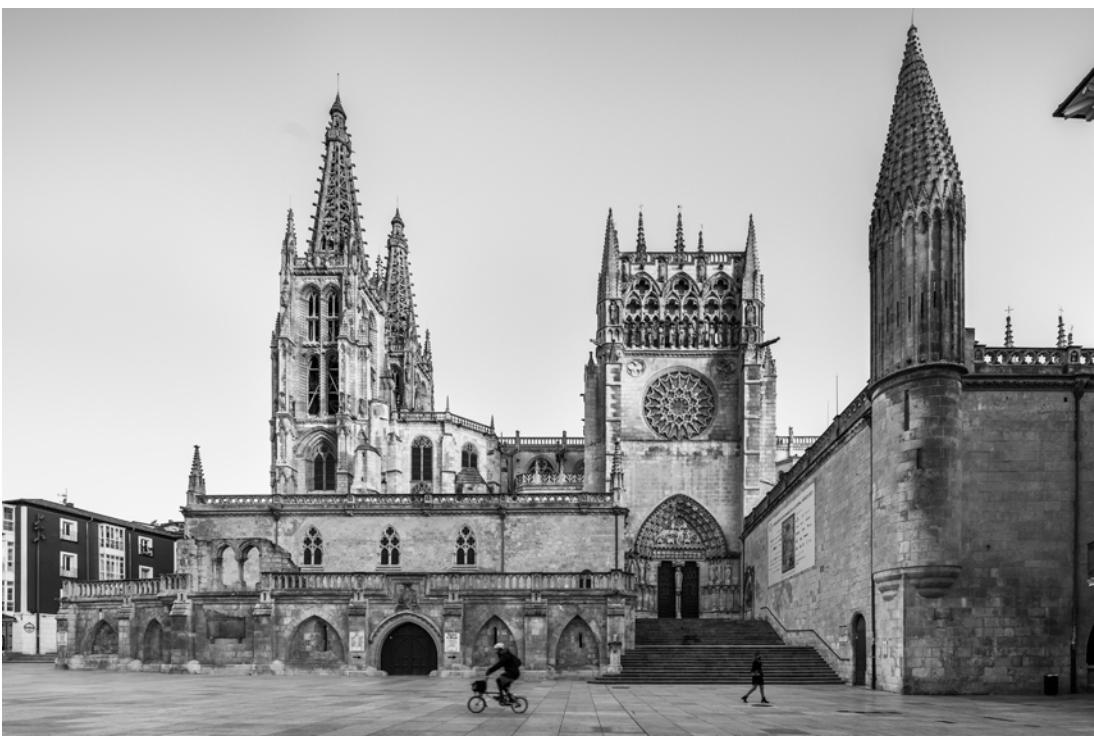
Fig. 15 - Current view of the space where the Archbishop's Palace was demolished a century ago. Photograph by Javier Bravo.

- Lighting and rendering. In this phase, a 360° photography of the current Rey San Fernando Square was taken in order to use it as global lighting so that it was in line with the actual lighting. Different spotlights were added, both direct lights and diffused lights, to set off the volumes of the building but respecting the actual location of the sun (fig.15) (fig.16).

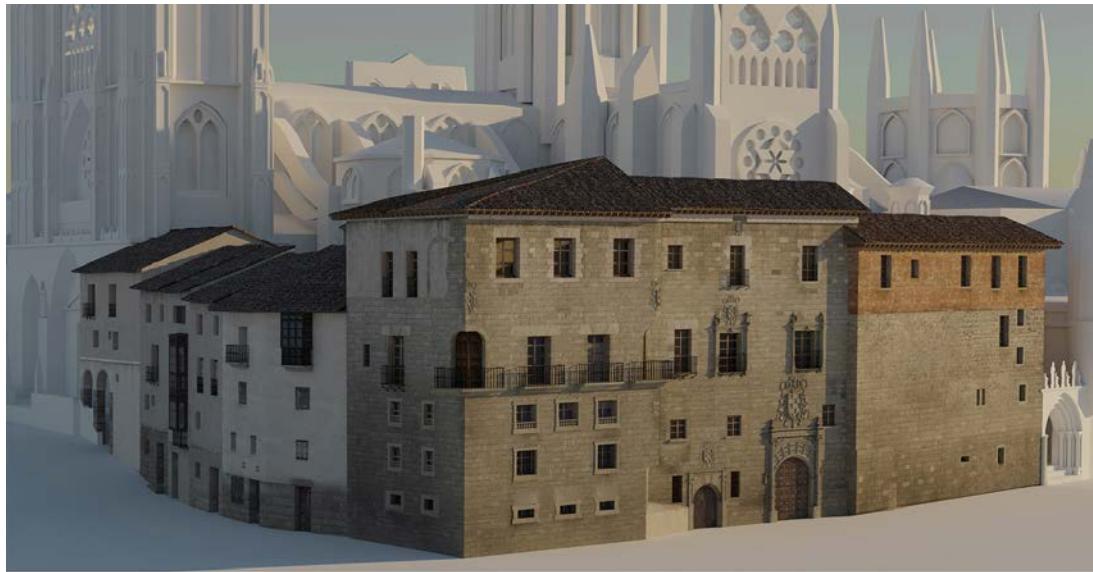
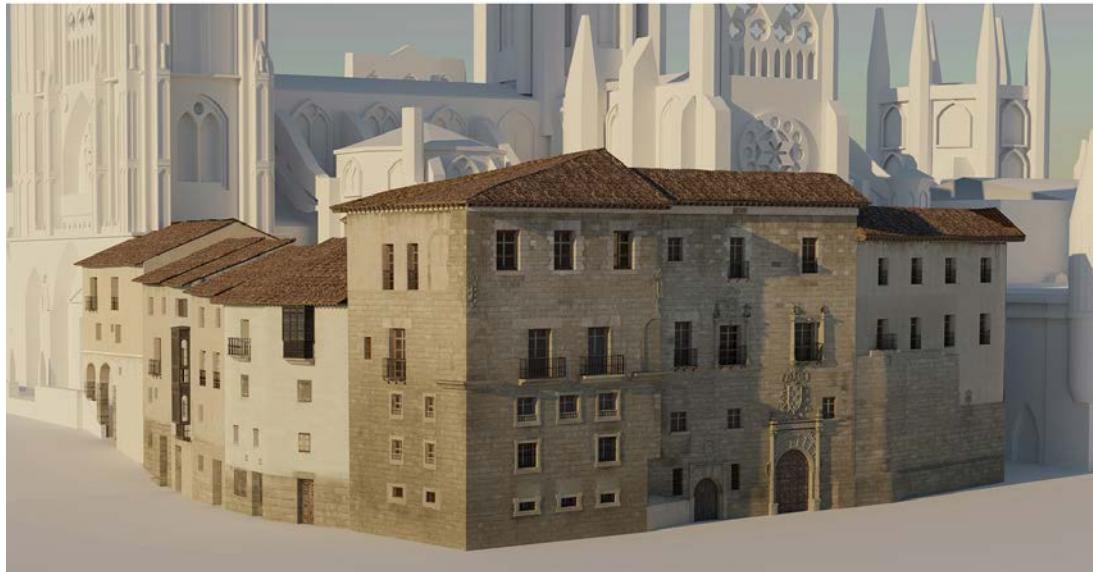
Fig. 16 - Surroundings of the Cathedral of Burgos before 1864, after 1868 and current state. Own Elaboration.

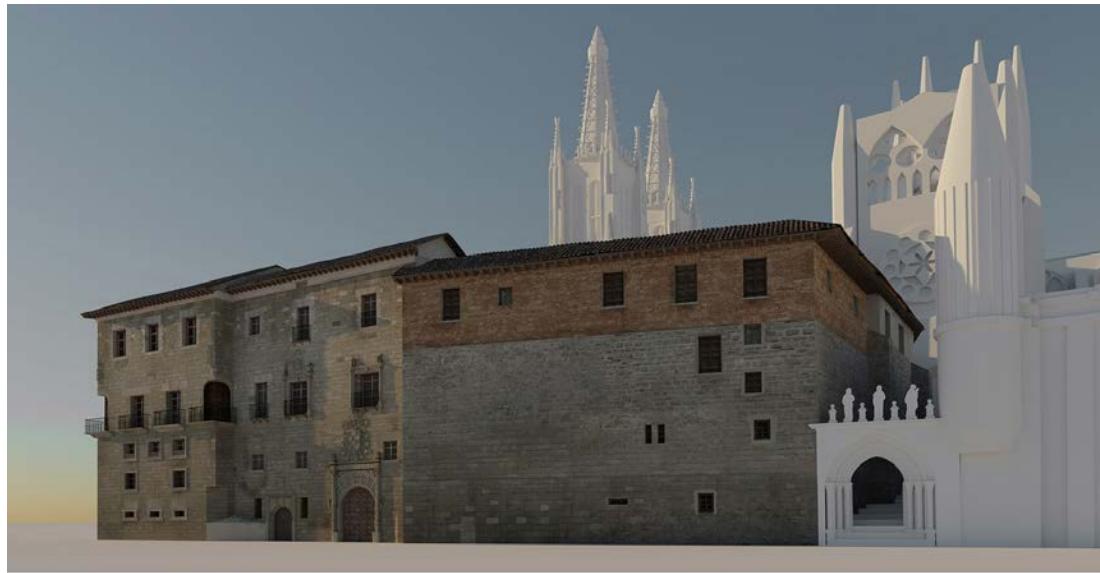
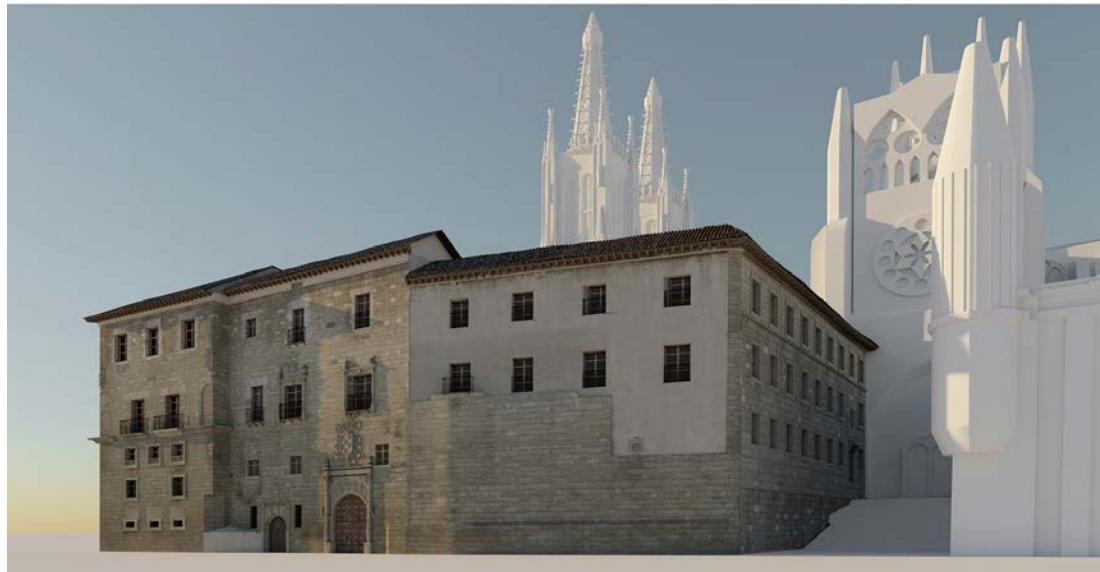
Fig. 17 - Infographic of the Archbishop's Palace before the 1864 remodeling seen from the southwest corner, where eastern end can be seen before the intervention. Own elaboration.

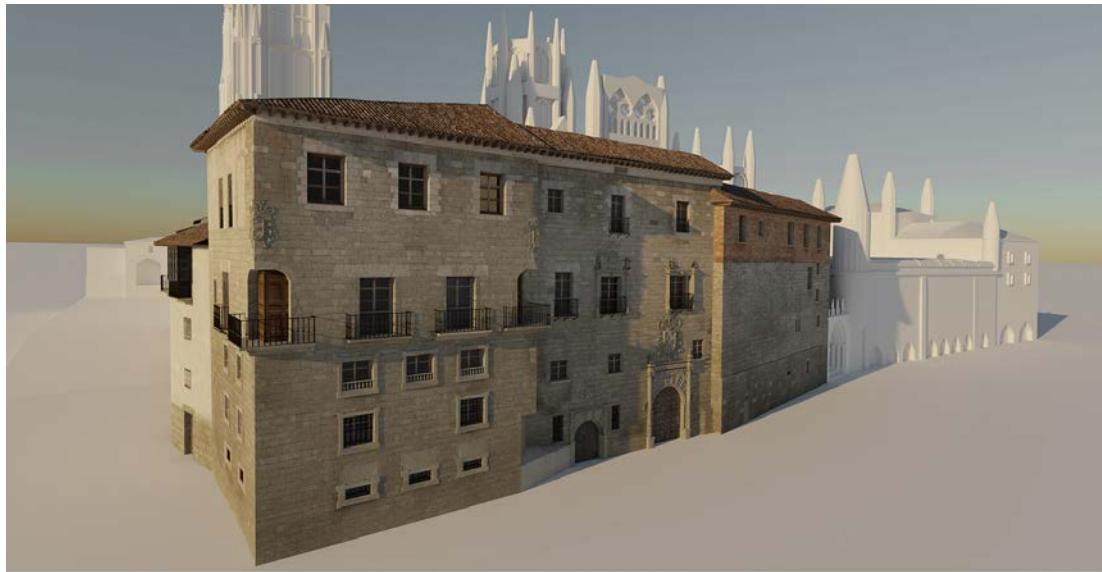
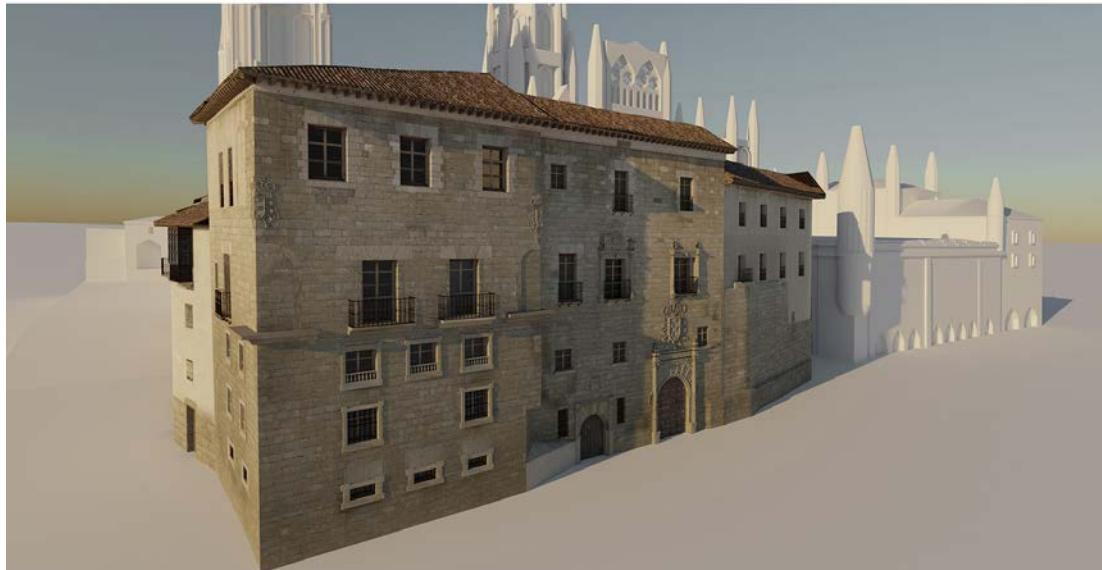
Fig. 18 - Infographic of the Archbishop's Palace before and after the 1864 remodeling seen from the southeast corner. Note how the eastern end hides the cover of the Sarmental. Own elaboration.
